SERVICE BULLETIN

Classification: EC12-010f Reference:

March 15, 2016

MIL ON WITH DTC P0106 STORED

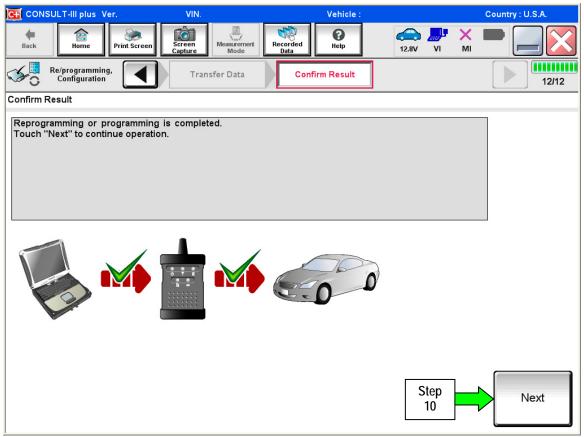
8. When the screen in Figure 4 displays, reprogramming is complete.

- 9. Disconnect the battery charger from the vehicle.
- 10. Select Next.
