NISSAN BULLETIN

Starter Motor Wire Dealer Inventory Inspection

Reference: PC440

PC440 Frontier (D40) Starter Motor Wire Position Inspection

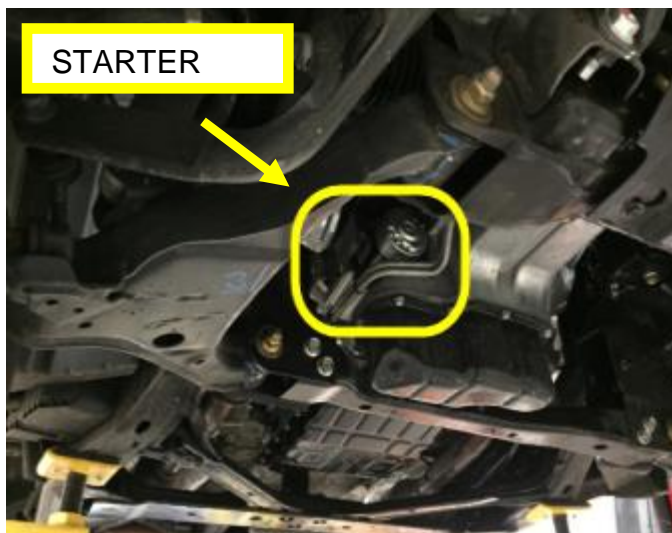
Figure 1
2 Wheel Drive

1. Pull the vehicle into a service bay with a lift.
2. Open the hood and disconnect the negative battery cable.
3. Raise the vehicle using the hoist.
4. Locate the starter motor (passenger side of engine) (Figure 1 & 2).

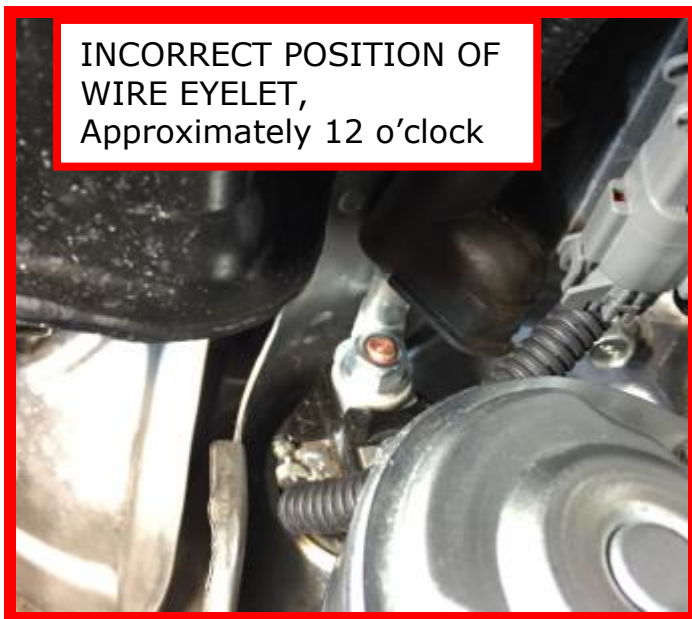
Figure 3

5. Gently pull the terminal protective boot back so that you can see the position of the starter motor wire eyelet (Figure 3 & 4).

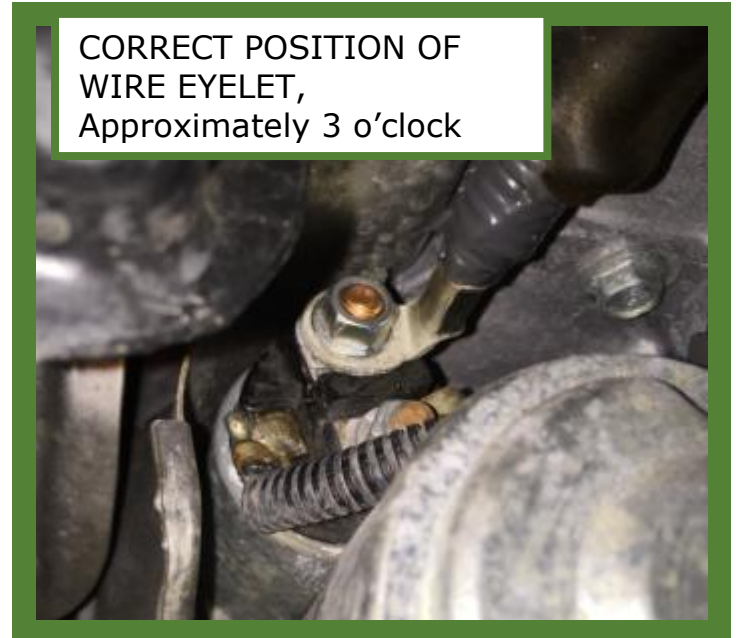
A. If the starter motor wire eyelet is in the **CORRECT** position (Figure 4):

- Loosen the starter motor wire nut and re-position the starter motor wire to be orientated as in Figure 4 above.
- Torque the starter motor wire nut:
11.0 Nm (97.0 Inch Lbs.)
- Gently push the terminal protective boot back over the nut and wire.
- Lower the vehicle off the hoist.
- Reconnect the negative battery cable.
- Submit a warranty claim using PC4401 per claims information, below.
- Release the vehicle.
