SERVICE BULLETIN

EC15-017

December 1, 2015

2014 – 2015 TAXI; MIL ON WITH DTC P0101

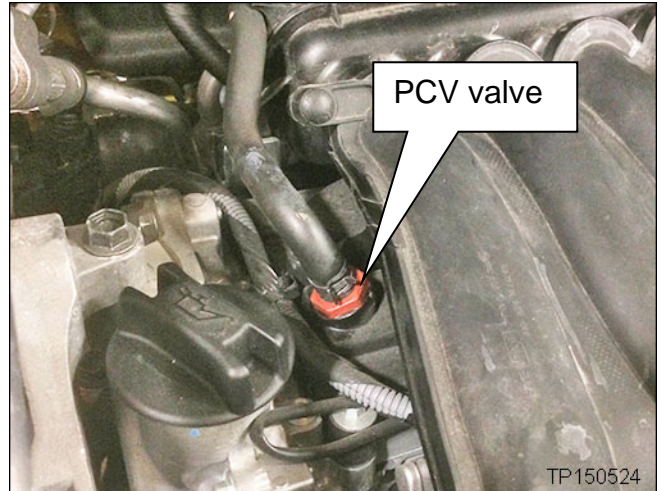
Figure A

The MIL is ON and DTC P0101 (MAF SEN/CIRCUIT-B1) is stored.

1. Open the engine hood and locate the PCV valve.
2. Replace the PCV valve:
 - If needed, refer to the Electronic Service Manual ESM, section EM-Engine Mechanical, for replacement information.
 - Use the new PCV valve listed in the Parts Information.
 - The new PCV valve is “black” color.
 - The old PCV valve (the one you are replacing) will likely be “orange” color.
