NISSAN BULLETIN

Rear Combination Lamp Assembly Dealer Inventory Service Action

Reference: PC438
Date: April 14, 2016

PC438 Titan – Rear Combination Lamp Assembly Inspection and Replacement

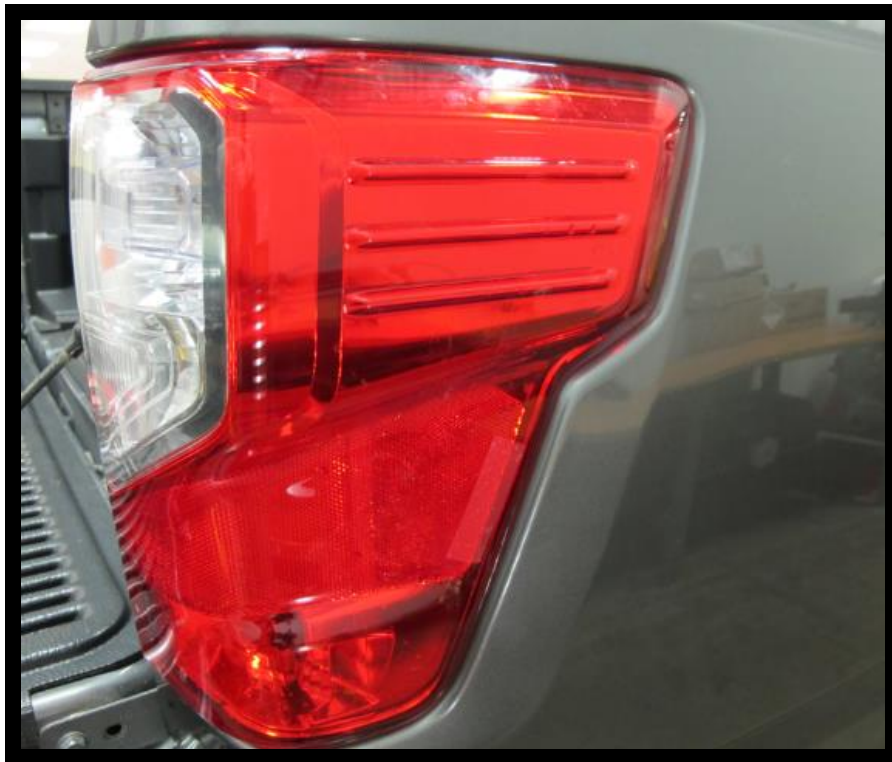
Figure 1

1. Park the vehicle in a safe working area and turn the ignition off.
2. Locate the Right (Passenger side) Rear Combination Lamp Assembly (Figure 1).

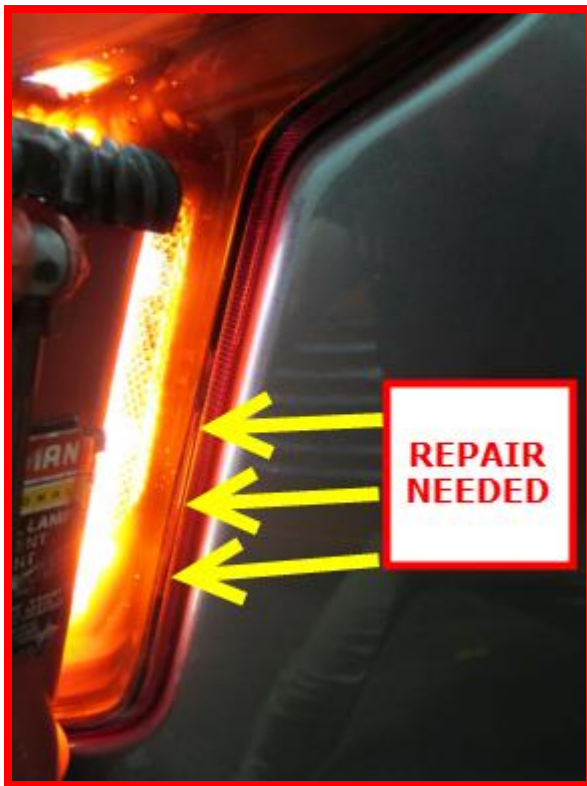
Figure 2

If there is no visible moisture present, look for a broken seam weld on the lamp assembly (Figures 2 & 3).

YES (**REPAIR NEEDED**) – Order a new rear combination lamp assembly. Go to Step 7 for rear combination lamp replacement.

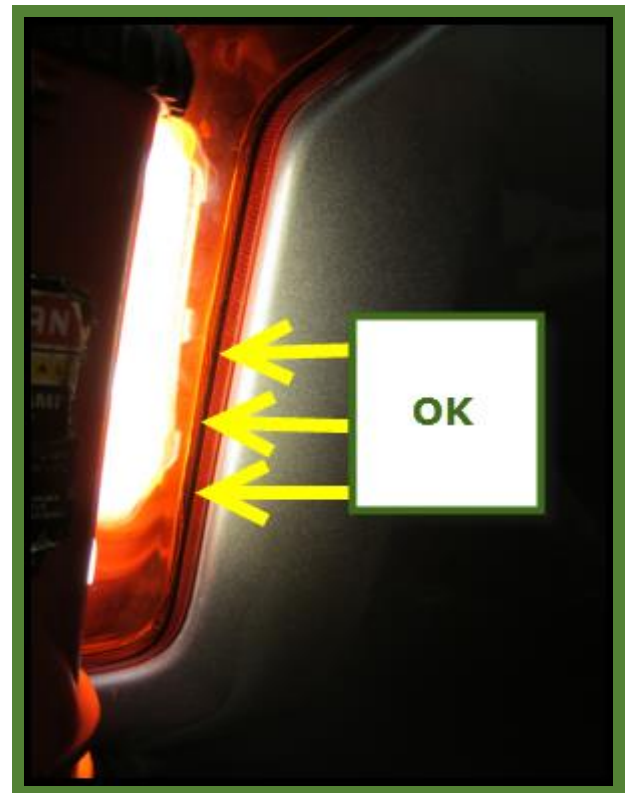
Figure 3

A continual black line will be present if lamp assembly is OK (Figure 3).

Continual BLACK line is present
