NISSAN BULLETIN

Engine Harness Ground Dealer Inventory Service Action

Reference: PC455
Date: April 14, 2016

PC455 - 2016 TITAN (A61) – ENGINE HARNES GROUND TORQUE

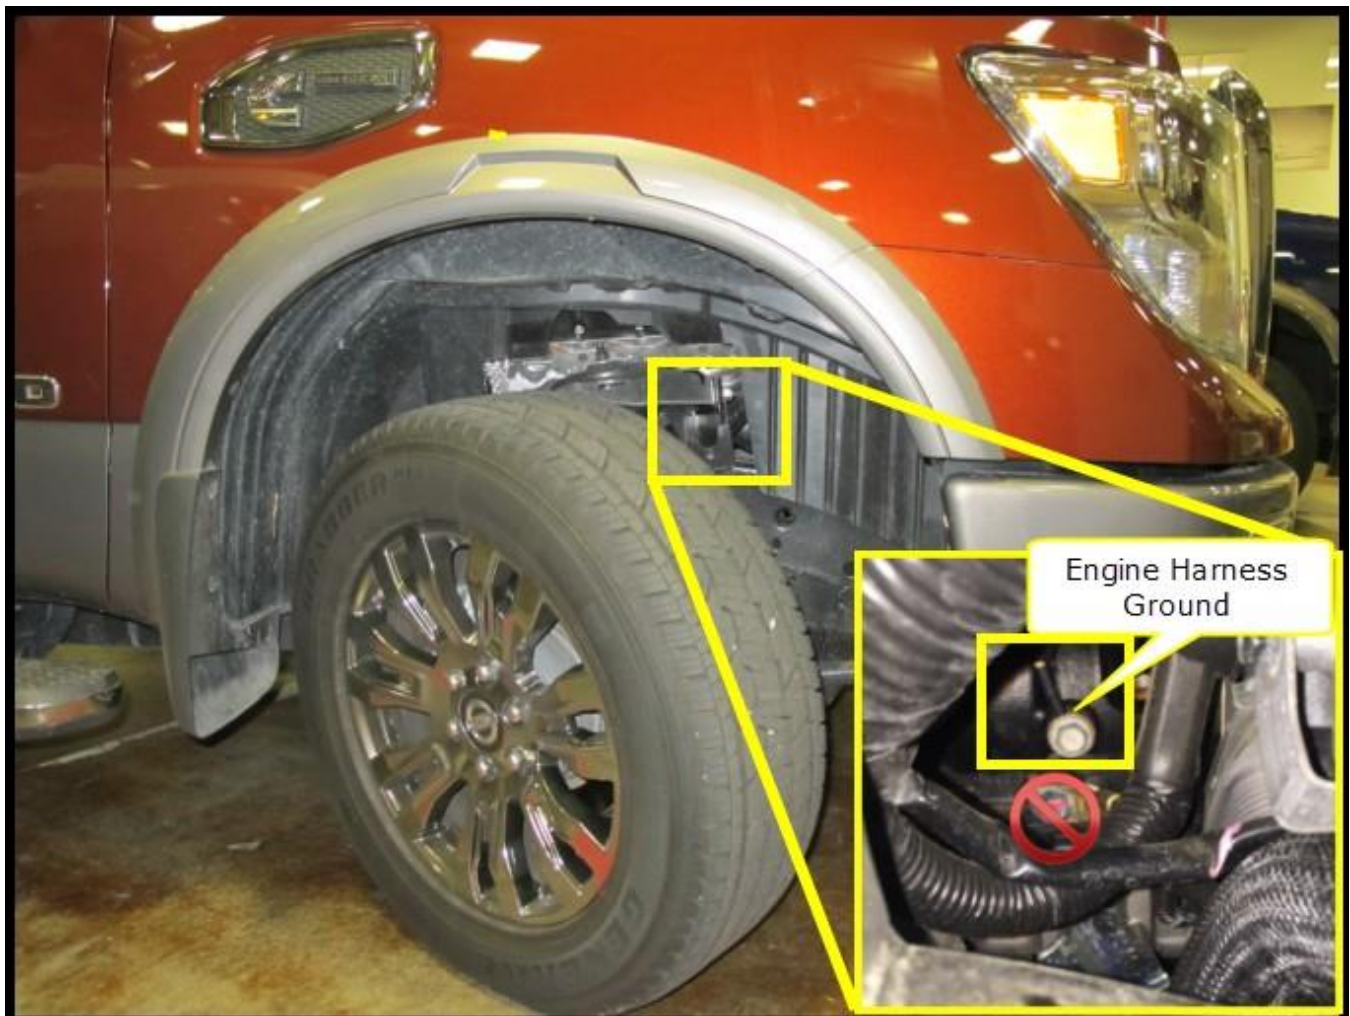
Figure 1

1. Park the vehicle in a safe location.
2. Turn the steering wheel fully to the right.
3. Locate the Engine Harness Ground by looking through the right front wheel well (Figure 1).

NOTE: There are 2 ground wires next to each other. Tighten the **UPPER** bolt for the Engine Harness Ground wire.
