SERVICE BULLETIN

Classification:	Reference:	Date:
EC16-016	NTB16-048	May 2, 2016

2016 TITAN XD; MIL ON WITH NOX SENSOR DTCs STORED

APPLIED VEHICLES: 2016 Titan XD (A61)
APPLIED VIN / DATE: Vehicles built before 1N6BA1F(*)GN 506505 / March 5, 2016
APPLIED ENGINE Cummins 5.0L V8 Diesel

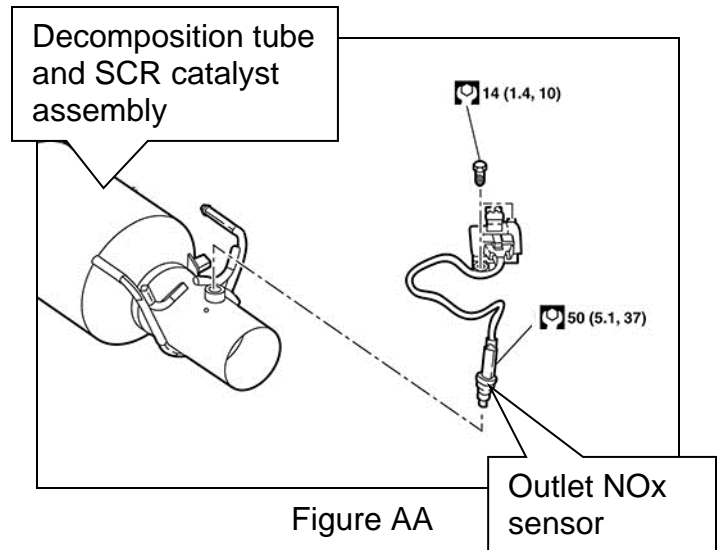
- Refer to the ESM, section **EX – Exhaust System** for removal and installation information.
- See Figure AA for location of the outlet NOx sensor.

Replace the Outlet NOx Sensor
