SERVICE BULLETIN

EC16-019

June 3, 2016

2013 – 2015 SENTRA; MIL ON WITH DTC P050B

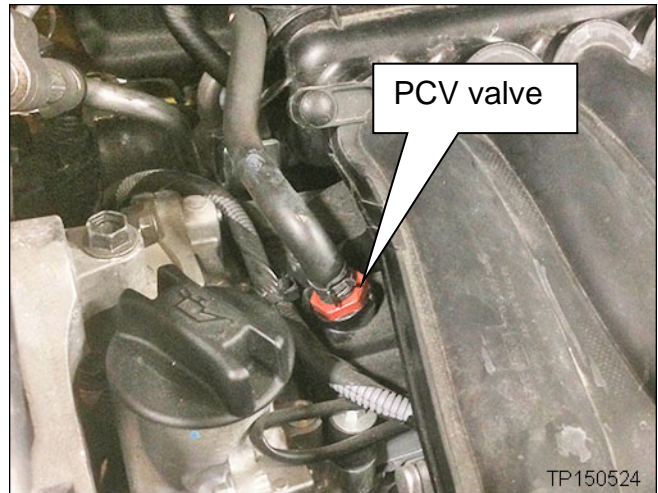
- Inspect the color of the PCV valve, replace if the color is orange (see Figure A on page 2).

If PCV valve is orange, as shown in Figure A:

- Replace the PCV valve.
- If needed, refer to the Electronic Service Manual ESM, section EM-Engine Mechanical, for replacement information.
- Use the new PCV valve listed in the Parts Information.
- The new PCV valve is “black” color.
