SERVICE BULLETIN

EC16-018

June 3, 2016

2016 MAXIMA; MIL ON WITH DTC P0507 STORED

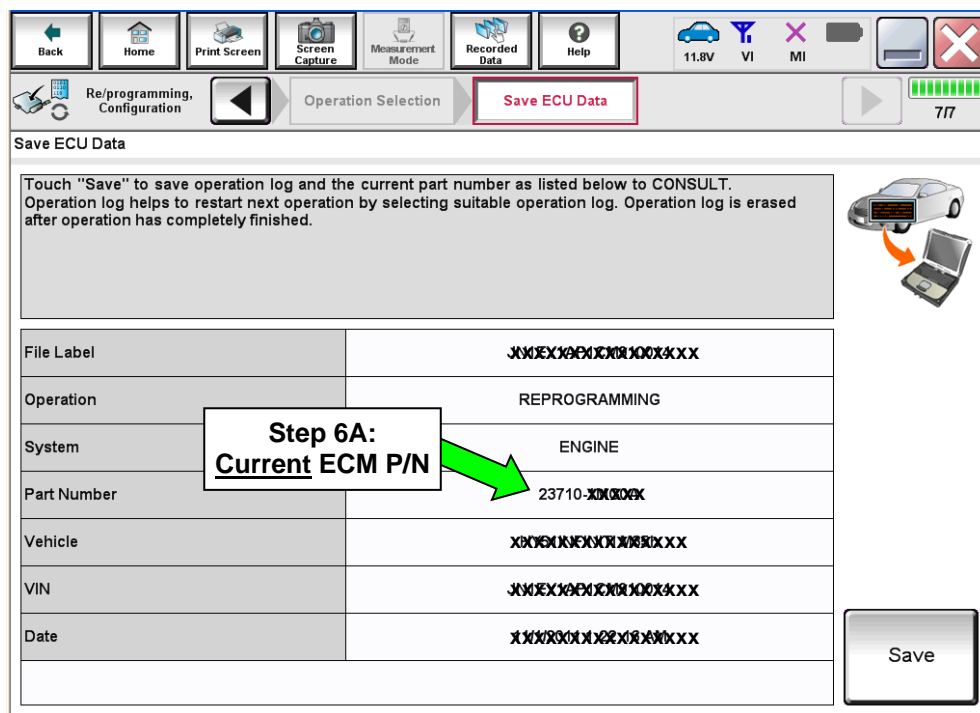
Figure 2

6. When you get to the screen shown in Figure 2, confirm this bulletin applies as follows.

A. Find the ECM **Part Number** and write it on the repair order.

NOTE: This is the current ECM Part Number (P/N).

B. Compare the P/N you wrote down to the numbers in the **Current ECM Part Number** column in **Table A** below.

- If there is a match, this bulletin applies. Continue with the reprogramming procedure.
- If there is not a match, this bulletin does not apply. Close C-III plus and refer to ASIST for further diagnostic information.

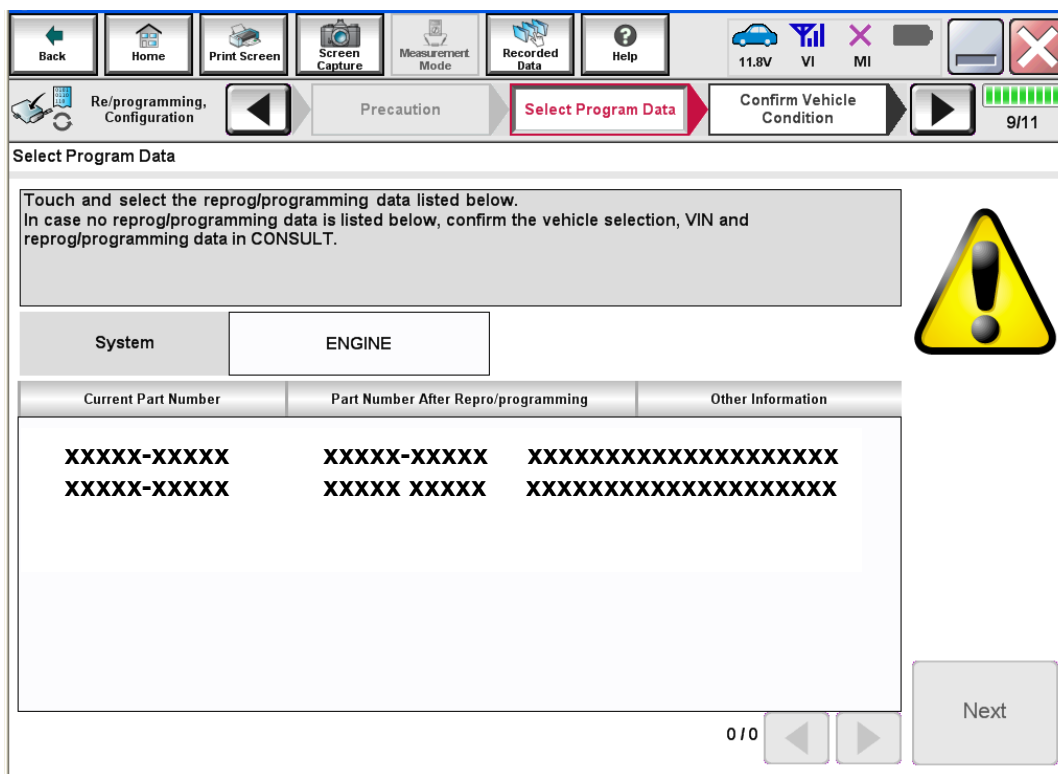
- In some cases, more than one new P/N for reprogramming is available.
 - If more than one new P/N is available, the screen in Figure 3 displays.
 - Select and use the reprogramming option that **does not** have the message “Caution! Use ONLY with NTBXX-XXX”.
- If you get this screen and it is blank (no reprogramming listed), it means there is no reprogramming available for this vehicle. Close C-III plus and refer back to ASIST for further diagnosis.

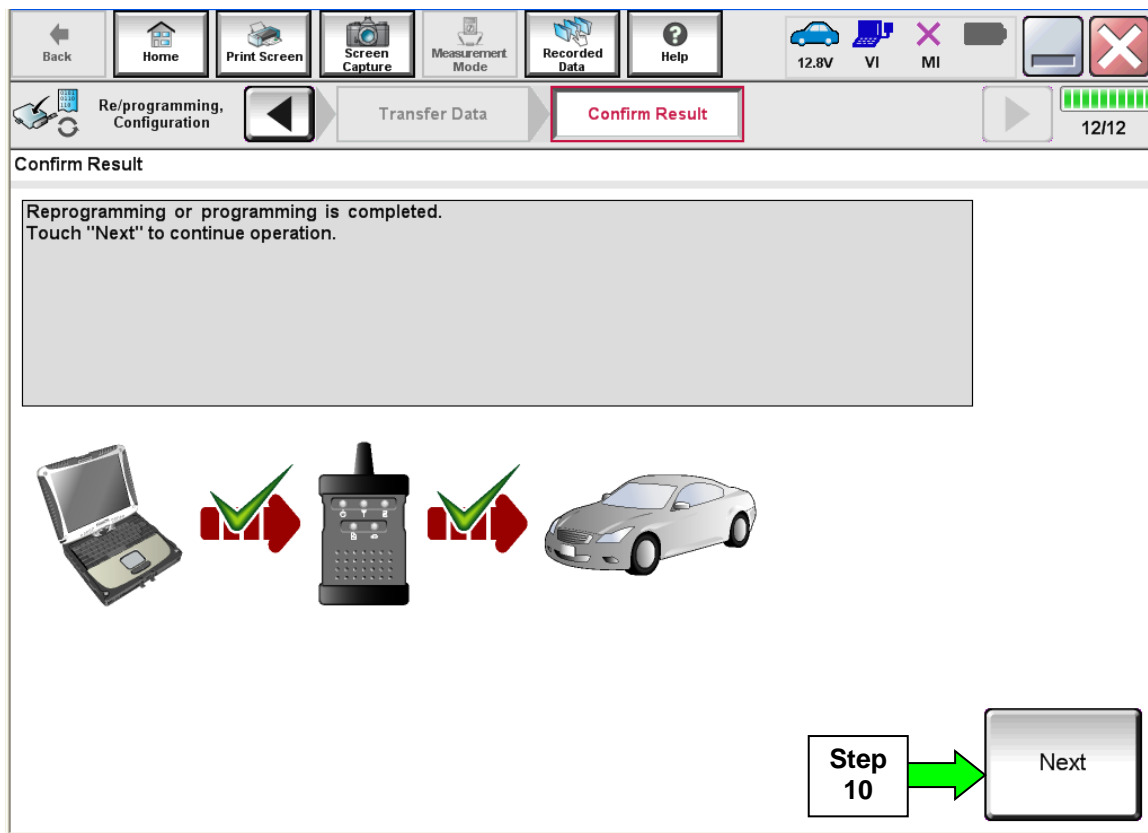
8. When the screen in Figure 4 displays, reprogramming is complete.

NOTE: If the screen in Figure 4 does not display (reprogramming does not complete), refer to ECM recovery on the next page.

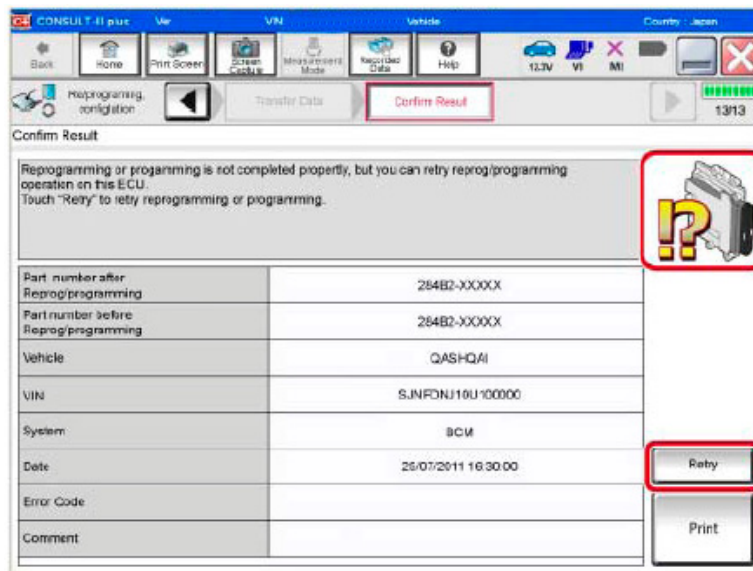
Figure 5

If reprogramming does not complete and the “!?” icon displays as shown in Figure 5:

- Check battery voltage (12.0 - 15.5 V).
- Ignition is ON, engine OFF.
- External Bluetooth® devices are OFF.
- All electrical loads are OFF.
- **Select retry and follow the on screen instructions.**
- “Retry” may not go through on first attempt and can be selected more than once.

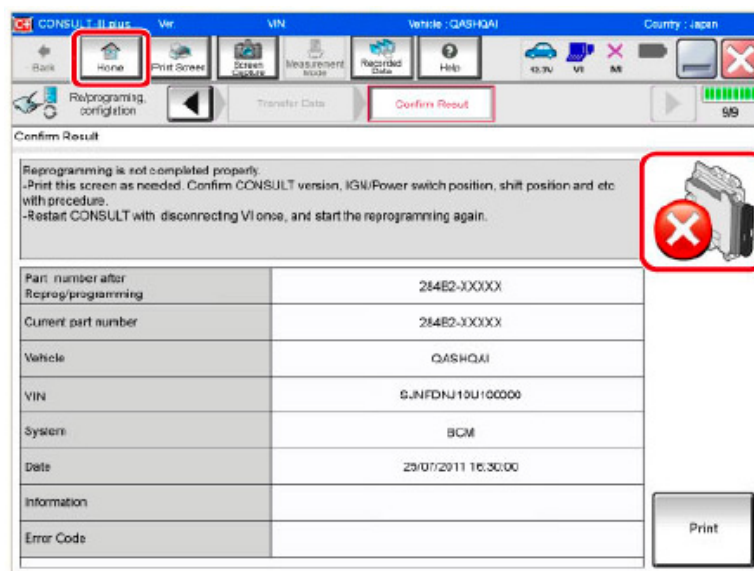
Figure 6

If reprogramming does not complete and the “X” icon displays as shown in Figure 6:

- Check battery voltage (12.0 - 15.5 V).
- CONSULT A/C adapter is plugged in.
- Ignition is ON, engine OFF.
- Transmission is in Park.
- All C-III plus / VI cables are securely connected.
- All C-III plus updates are installed.
- **Select Home, and restart the reprogram procedure from the beginning.**

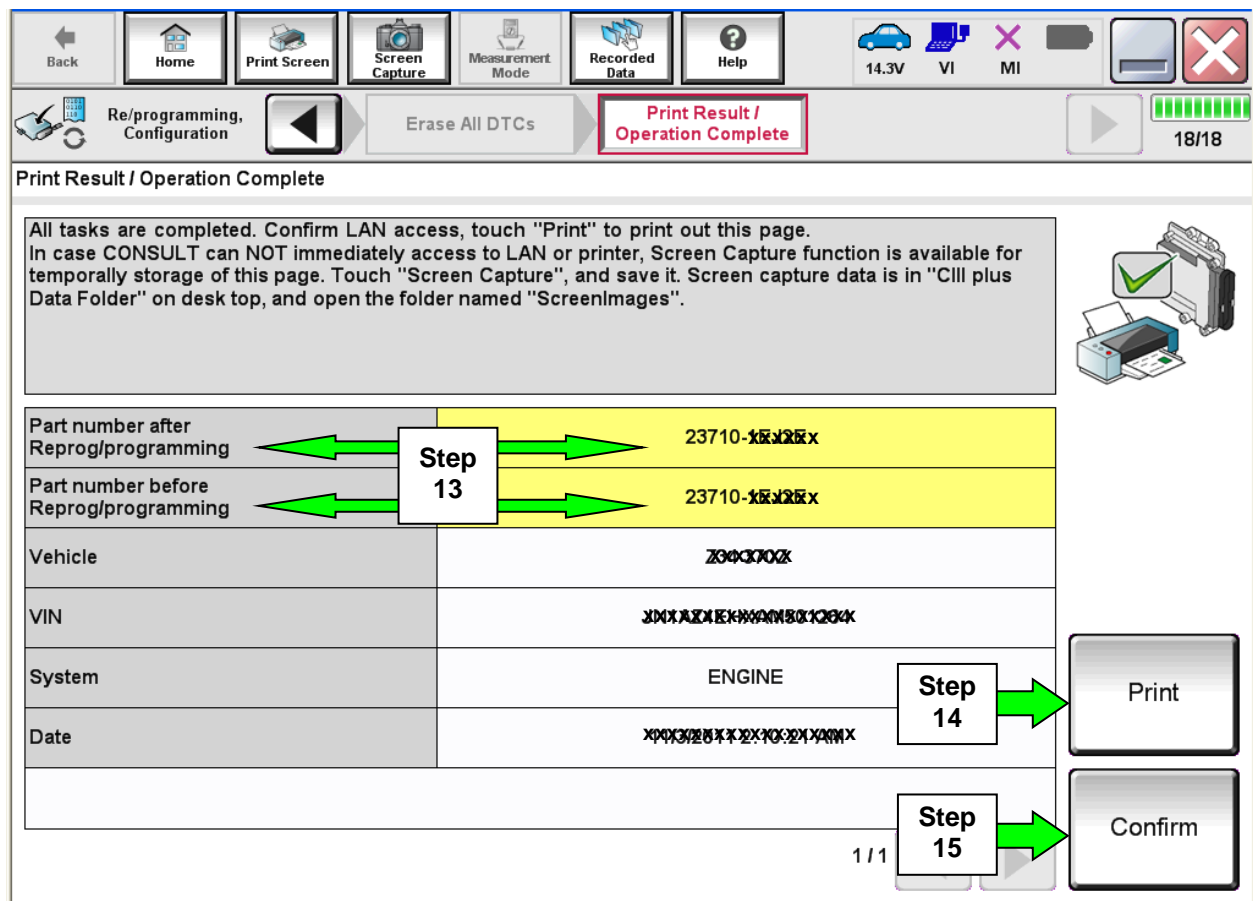
12. When the entire reprogramming process is complete, the screen in Figure 7 will display.
13. Verify the before and after part numbers are different.
14. Print a copy of this screen (Figure 7) and attach it to the repair order for warranty documentation.
15. Select **Confirm**.
