SERVICE BULLETIN

EC16-020

June 20, 2016

2015-2016 JUKE; MIL ON WITH DTC P050B

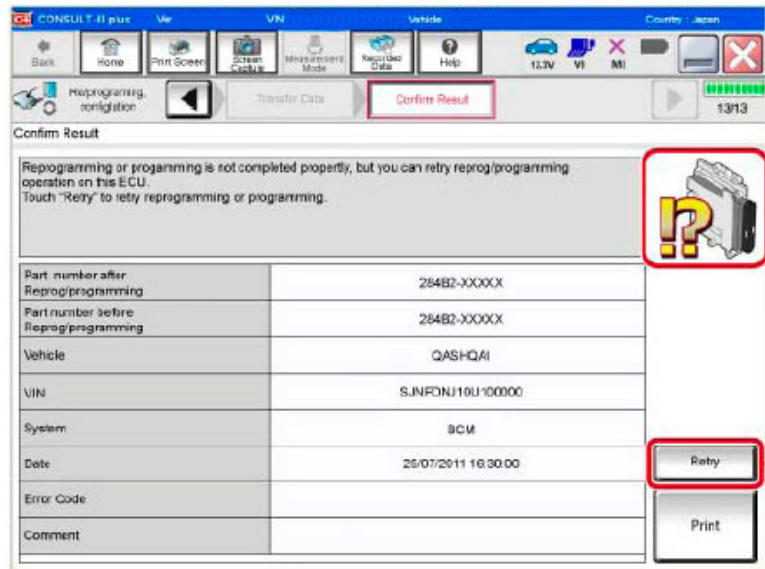
Figure 5

If reprogramming does not complete and the “!?” icon displays as shown in Figure 5:

- Check battery voltage (12.0–15.5 V).
- Ignition is ON, engine OFF.
- External Bluetooth® devices are OFF.
- All electrical loads are OFF.
- **Select retry and follow the on screen instructions.**
- “Retry” may not go through on first attempt and can be selected more than once.

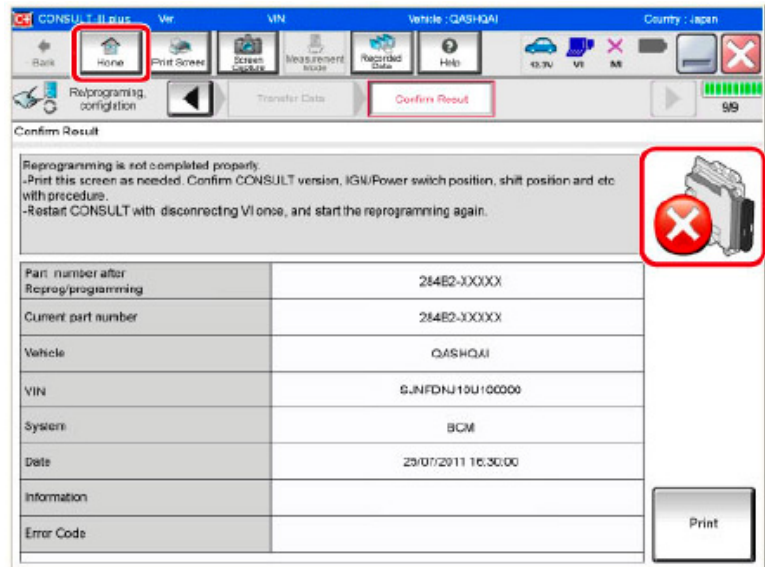
Figure 6

If reprogramming does not complete and the “X” icon displays as shown in Figure 6:

- Check battery voltage (12.0 – 15.5 V).
- CONSULT A/C adapter is plugged in.
- Ignition is ON, engine OFF.
- Transmission is in Park.
- All C-III plus / VI cables are securely connected.
- All C-III plus updates are installed.
- **Select Home, and restart the reprogram procedure from the beginning.**
