Technical Journal

Sensus Navigation. IAM 2.1 software upgrade to allow map upgrade via USB

REF NO:
TJ 31762.1.0

ISSUE DATE:
2016-10-21

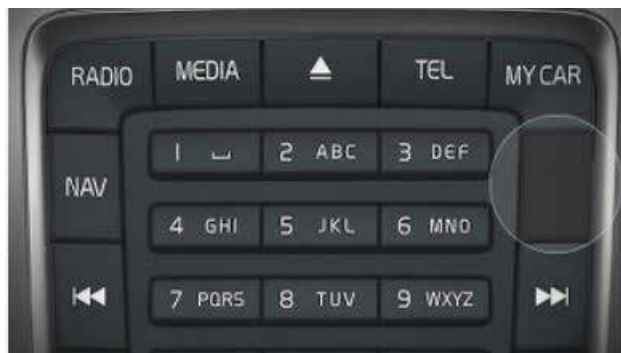
File Name	File Size
SENSUS RTI IAM.JPG	0.0195 MB

Map updates for Sensus navigation systems in MY2011-2015A cars (identified as shown in attached picture) can now be downloaded online and transferred to the car via a USB flash drive in the same way as current models. **Updating via DVDs is no longer possible.**

To allow map upgrades via USB, the IAM software must be upgraded to the latest status.
