TITLE:
Replace MMS with IMS

REF NO: TJ 31847.1.0	ISSUING DEPARTMENT: Technical Service	CAR MARKET: United States and Canada	
PARTNER: 3 US 7510 Volvo Car USA		ISSUE DATE: 2016-11-03	STATUS DATE: 2016-11-07
FUNC GROUP: 3662	FUNC DESC: Burglar alarm equipment	Page 1 of 5

TJ Instruction T9388

Title	Intrusion sensor	Page:	1 (3)
Action	Modification	Operation number:	98638-2

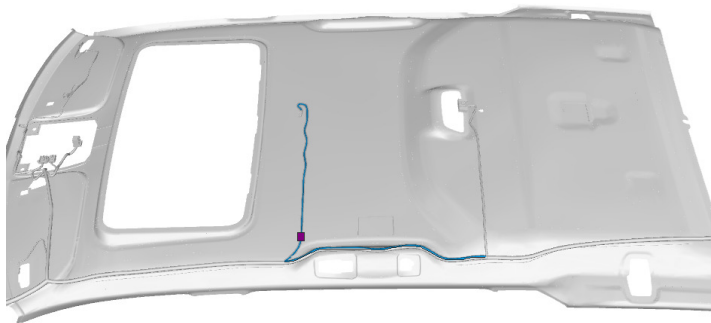
2.

The front MMS (MMS2) is no longer available as spare part. The vehicle can be adapted to use an IMS instead.

Route the cable to rear sensor and connect the adapter cable

Attached the cable with melting adhesive

Note! Use a new headlining
