TITLE:
Replace MMS with IMS

REF NO: TJ 31847.1.0	ISSUING DEPARTMENT: Technical Service	CAR MARKET: Canada	
PARTNER: 3 US 7510 Volvo Car USA		ISSUE DATE: 2016-11-03	STATUS DATE: 2016-11-08
FUNC GROUP: 3662	FUNC DESC: Burglar alarm equipment	Page 1 of 5

TJ Instruction T9388

Title	Intrusion sensor	Page:	1 (3)
Action	Modification	Operation number:	98638-2

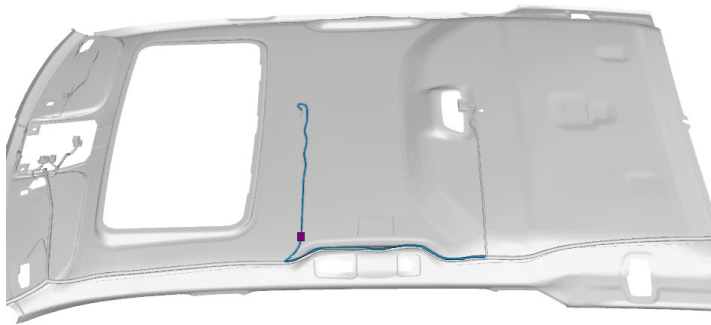
2.

Route the cable to rear sensor and connect the adapter cable

Attached the cable with melting adhesive

Note! Use a new headlining
