**Leather seats, improvements on wrinkles and wear**

REF NO:  
**TJ 32005.1.0**

# Nappa leather improvements

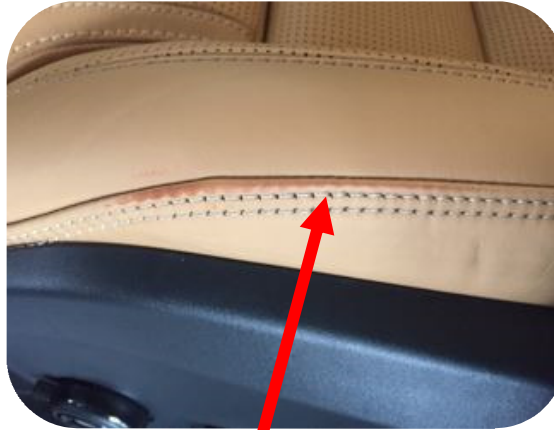
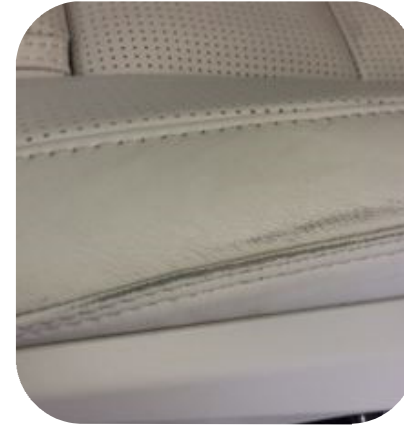
Early wear on top of bolster seam and cushion.  
(Cloth is folded to one side, which gives a higher level.)

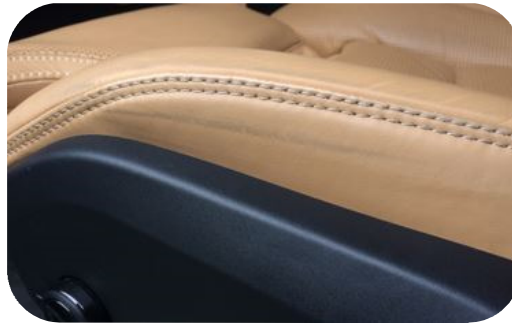
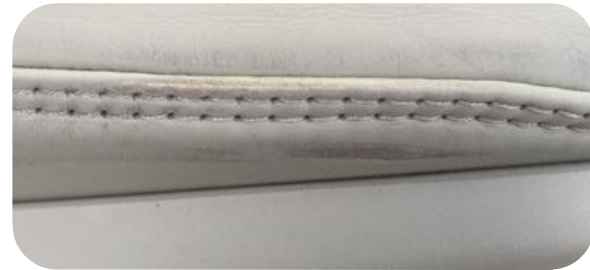
Early wear on outside of bolster cushion.

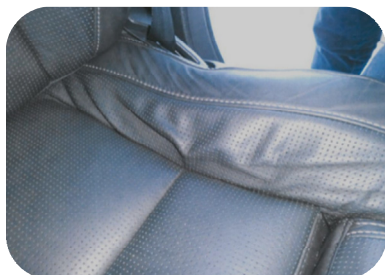
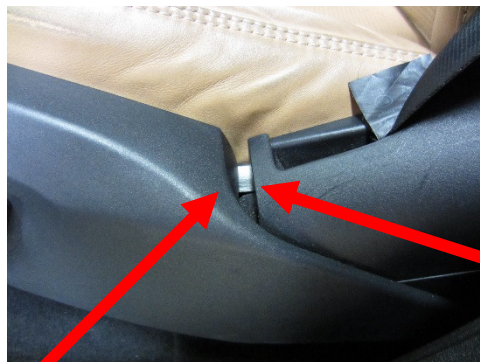
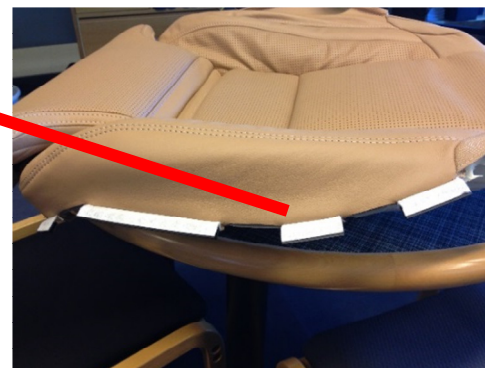
Side bolster wrinkles (Clist comes loose and a white piece can be seen.)

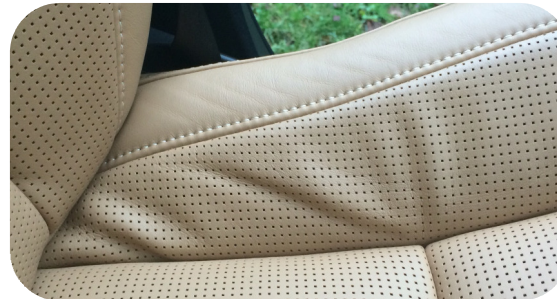
Side bolster wrinkles
