Service Action S39810: ABS wiring

REF NO: TJ 32069.1.1	ISSUING DEPARTMENT: Technical Service	CAR MARKET: United States and Canada	
PARTNER: 3 US 7510 Volvo Car USA		ISSUE DATE: 2016-10-31	STATUS DATE: 2016-11-08
FUNC GROUP: 3700	FUNC DESC: Cables and fuses	Page 1 of 5

Title	S39810, ABS wiring	Page	1 (3)
Action	Inspection

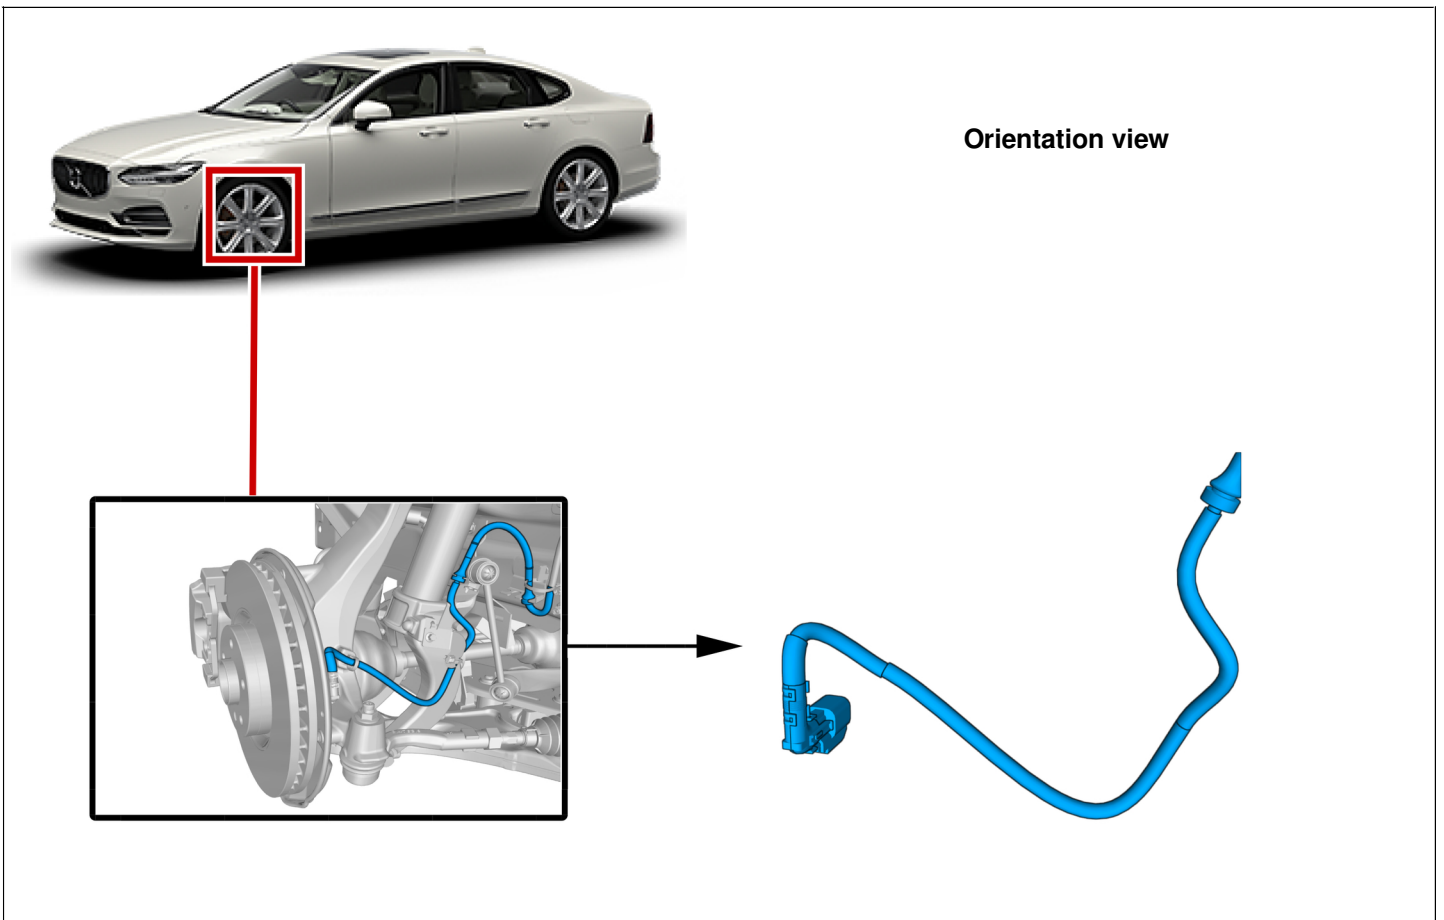
Volvo has identified that the ABS (Antilock Brake System) wiring may chafe against the front driveshaft bellow. This condition will light a yellow Electronic Stability Control, (ESC) and red (ABS) warning lamp, and a text message "ABS/ESC temporarily off" will appear in the instrument panel. If the fault is detected as permanent, a message "Brake system service required" will be also appear in the instrument panel.

With the vehicle on a flat surface with the wheels pointing straight ahead, measure the distance on both sides of the vehicle.

If the distance is 20mm or more, no action is needed.

If the distance is less than 20mm, the wiring needs to be repositioned according to the following steps.
