Technical Journal

Seat hard to push back, second row seat (7 seater)

REF NO: TJ 32025.1.0	ISSUING DEPARTMENT: Technical Service	CAR MARKET: United States and Canada	
PARTNER: 3 US 7510 Volvo Car USA		ISSUE DATE: 2016-11-21	STATUS DATE: 2016-11-28
FUNC GROUP: 8531	FUNC DESC: Rear seat, complete	Page 1 of 6

Second row in 7-seater: Hard to fold back backrest

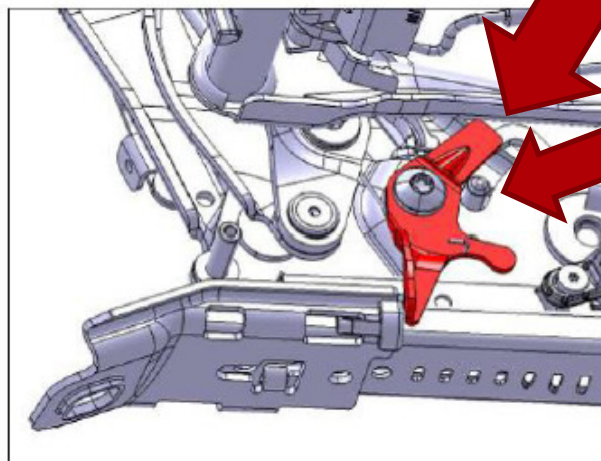
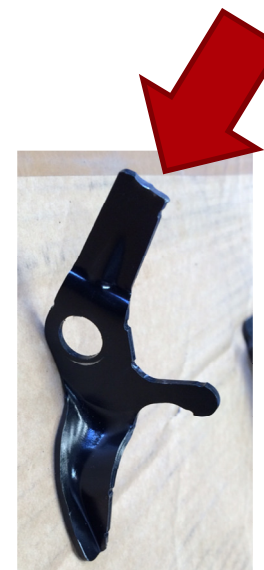
- Outer seat in Second row is hard to move back after entrance to third row.
- Backrest folds back too early (before seat is slided back).

Stopping edge of rebound bracket wear against the stop screw. This wear prevents it from releasing.

- Replace the rebound bracket.
- New concept "knee lever" to be introduced.

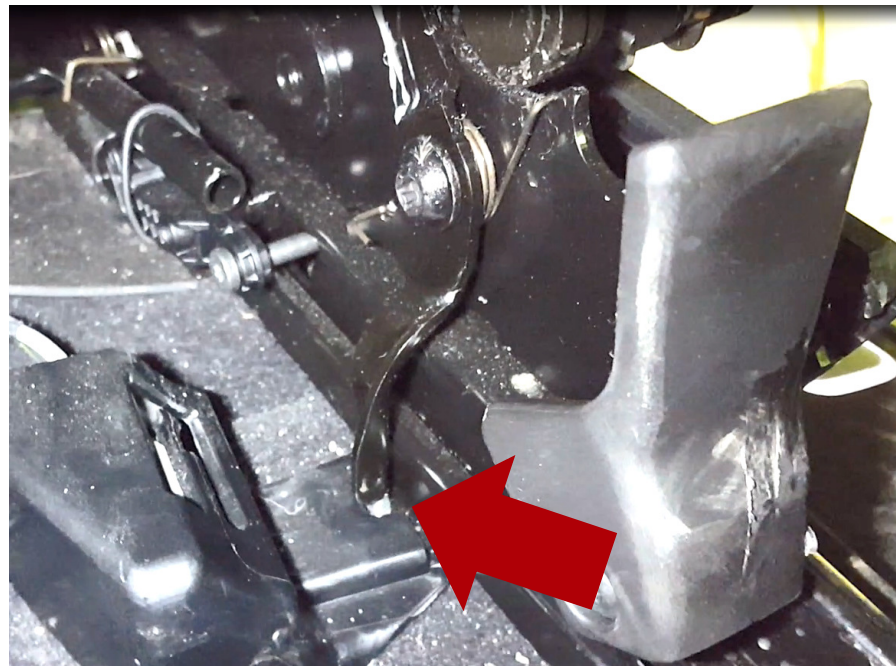
Outer seat in second row is hard to move back after entrance to third row.

Lower part of rebound bracket sticks on screw head.

- Grind down the screw head.
- New concept with lower screw head.

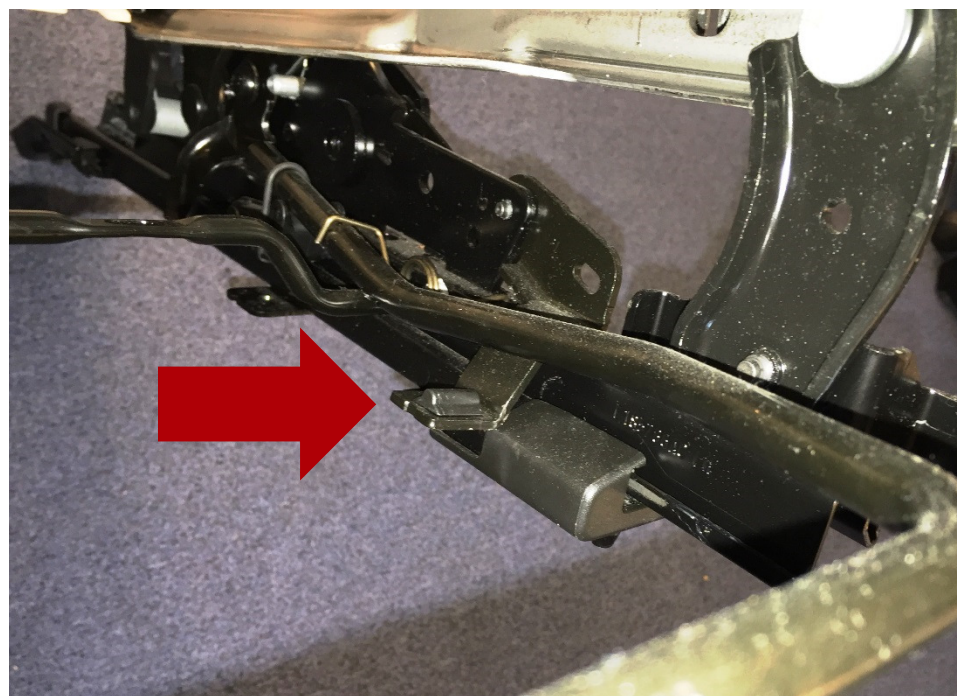
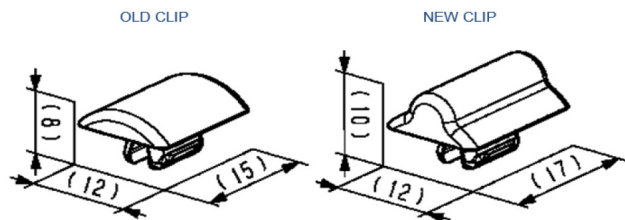
Outer seat in second row is hard to move or makes rattling noise over the rails.

Plastic stoppers for adjustment lever forward/backward too low.

Replace stoppers to new, higher model.
No p/n change, use the VIDA part number.

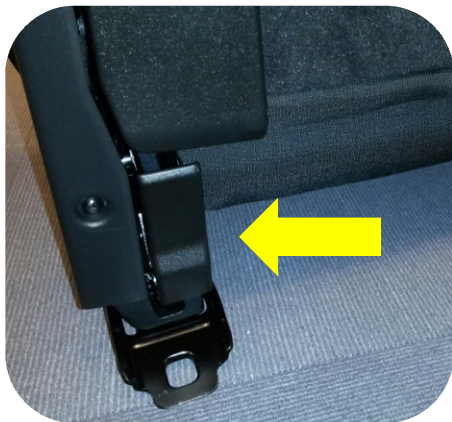
Issue: Second Row outer seat, 7 seater

Gap closer can get stuck and damaged when back rest is folded back.
To avoid on current cars: Always start from normal position when seat are supposed to be flat folded. (Do not start from easy entry position.)

Solution step 1 Current Gap closer will be redesigned.
