**Technical Service Note 31-09** (Rev. “C”- Torque change.)

**SUBJECT:** Fifth Wheel Plate to Outboard Mounting Angle Fasteners.

**PRODUCTS:** Cascadia vehicles equipped with plate mounted fifth wheels and outboard mounting angles.

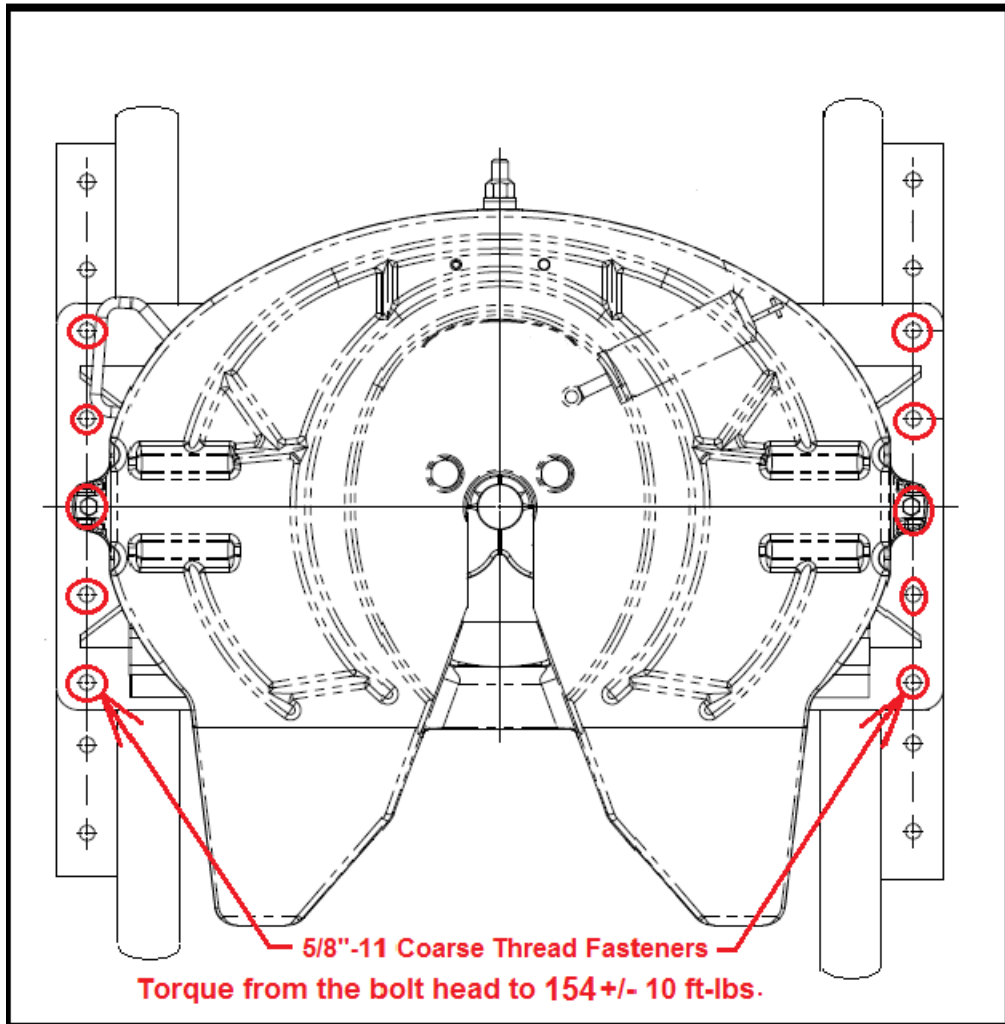
**PROBLEM / SYMPTOMS:** Customer complaints of loose fasteners at the fifth wheel plate to outboard angles.

Inspect the ten 5/8” fasteners that attach the fifth wheel plate to the outboard angles to confirm they are torqued to the appropriate specification.

**If any of the fasteners are below the minimum torque, replace all ten fasteners with new hardware.**

**If the Fifth Wheel is being relocated to an alternate position on the outboard angles replace all ten fasteners with new hardware.**

**Note: Torque from the bolt head to 154 +/- 10 ft-lbs.**
