## **Technical Service Note 32-07**

**SUBJECT:** Steer Axle Spring to Bracket Thru Bolt Torque check.

**PRODUCTS:** Freightliner vehicles equipped with the 12,000 lb & 13,300 lb Steer Axle Suspension with the thru-bolt spring to bracket design.

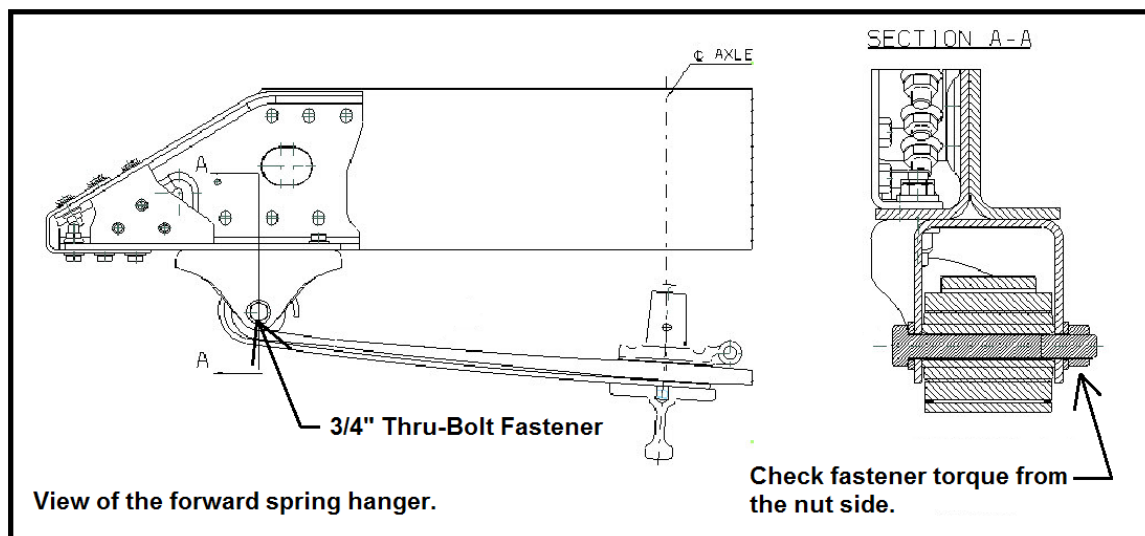
Fig. 1

**PROBLEM / SYMPTOMS:** Incorrect fastener clamp load at the steer axle to bracket thru-bolt at the forward and/or rear shackle brackets.

1. Shutdown the engine and chock the wheels.
2. Check the static torque at the two (2) front spring eye fasteners and four (4) rear shackle bracket fastener locations.
3. Set the torque wrench to **200** foot pounds and check the torque at all six locations as shown in Figure 1. & 2. Use a calibrated torque wrench and a backing wrench to hold the fastener, check the torque at the nut in a tightening direction.
4. If no nut movement is observed set the torque wrench to 241 ft lbs and retorque the existing fastener.
5. If nut movement is observed (torque is found to be less than 200 ft lbs) replace the  $\frac{3}{4}$ " fastener and retorque to 241 ft lbs. Refer to Table 1. for a list of fastener part numbers.
