## **Technical Service Note 32-11**

**SUBJECT:** Airliner Rear Suspension Spring Bar Pin Fasteners.

**PRODUCTS:** Freightliner and Western Star vehicles equipped with an Airliner rear suspension.

**PROBLEM / SYMPTOMS:** Airliner spring bar pin to suspension hanger bracket fastener torque check.

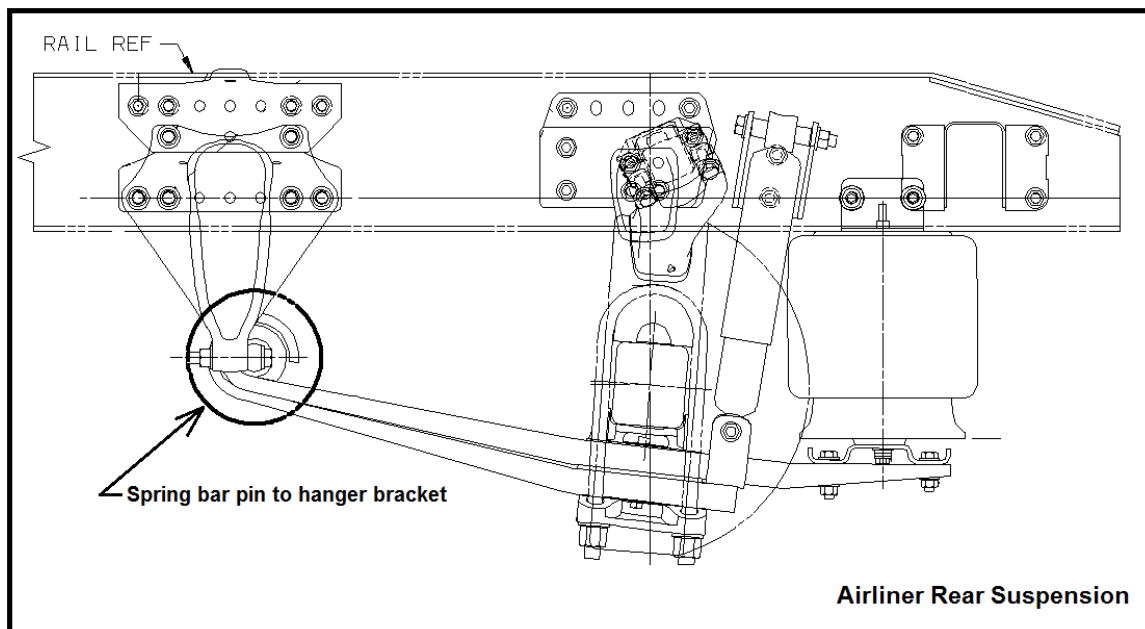
Illustration 1

Inspect the two 3/4"-10 coarse thread fasteners at each of the airliner spring bar pin to the suspension hanger brackets to confirm they are torqued to the appropriate specification.

- Using a calibrated torque wrench set to 165 ft lbs and a backing wrench to hold the fastener, check the torque at the nut in a tightening direction.
- If no nut movement is observed set the torque wrench to 200 ft lbs and retorque the existing fastener.
- If nut movement is observed (torque is found to be less than 165 ft lbs) replace the 3/4" fastener and torque from the nut to 200 ft lbs.

- Using a calibrated torque wrench set to 200 ft lbs and a backing wrench to hold the fastener, check the torque at the bolt head in a tightening direction.
- If no bolt movement is observed set the torque wrench to 241 ft lbs and retorque the existing fastener.
- If bolt head movement is observed (torque is found to be less than 200 ft lbs) replace the 3/4" fastener and torque from the bolt head to 241 ft lbs.

**If either of the fasteners are below the minimum torque, replace both fasteners with new 3/4-10 coarse thread hardware.**
