Tech Article

TA0006: Instrument Gauge Display Streaking

Reference	TA0006
Last Modified	January 27, 2016
Models	<i>2014 and later vehicles:</i>
Markets	Global
Category	Electrical
Symptoms	Streaking appearance or film residue on the inside of instrumentation gauges.

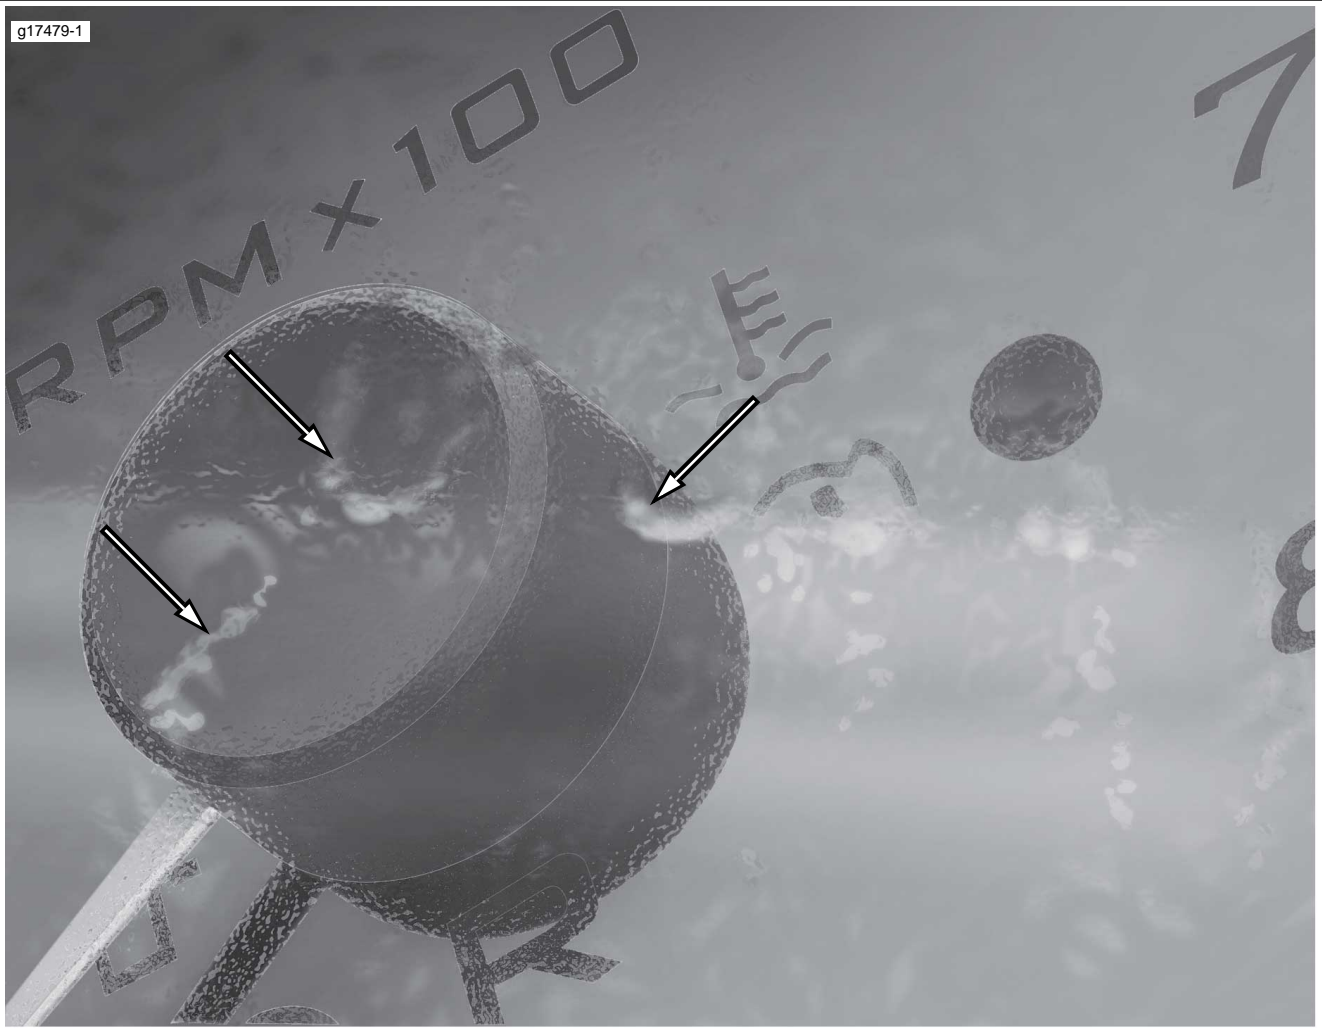
See Figure 1. Harley-Davidson is aware of conditions that may result in a streaking appearance or film residue on the inside of some instrument gauges including speedometer and tachometers. This may occur after exposure of the vehicle to humid conditions. This condition may remain even after the moisture has evaporated.

Figure 1. Speedometer Streaking

While this condition is warrantable, there is a high probability that the replacement part will exhibit the same condition at this time. Consider this when reviewing the issue and possible repairs to any affected vehicles. Harley-Davidson is aware of the condition and working toward a resolution.
