# TT450: STREET STARTER CABLE ROUTING

January 14, 2016

| APPLIES TO | SYMPTOMS |
|---|---|
| All 2015-2016 XG500 and XG750 Models | <ul style="list-style-type: none"><li>• Driveability or Performance Concerns</li><li>• Intermittent or Erratic Electrical Operation</li></ul> |

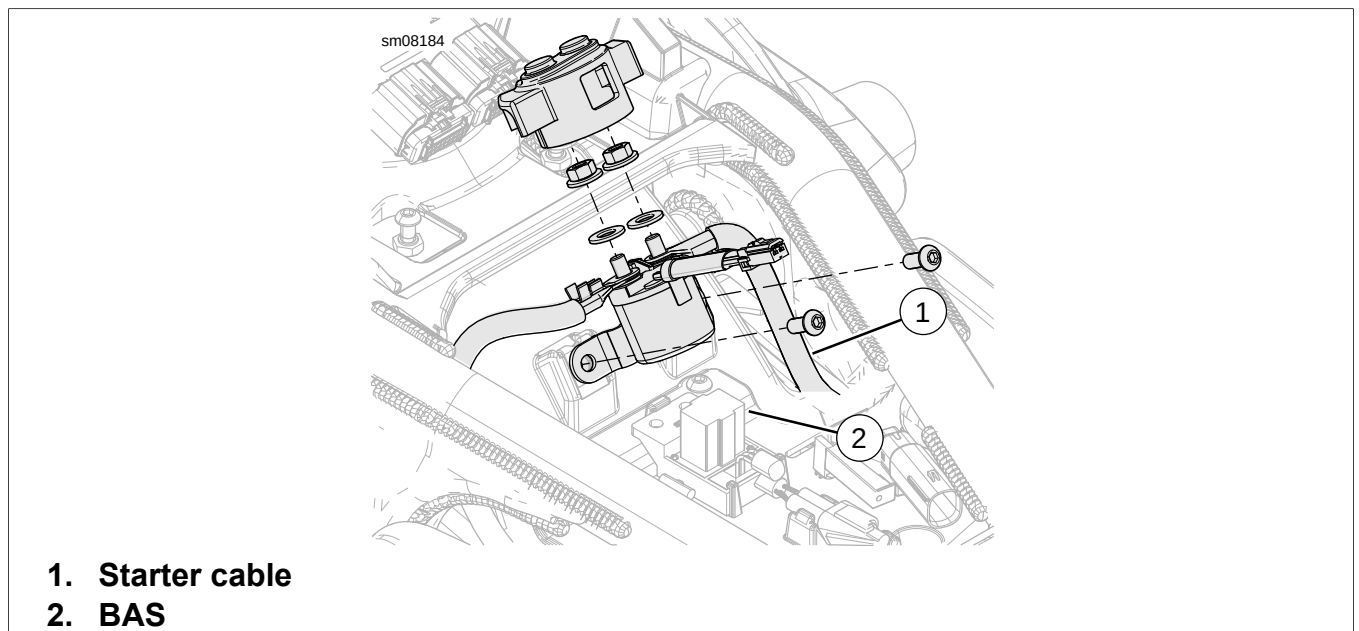
Figure 1. BAS

Improperly routed starter cable near the bank angle sensor (BAS) can cause this condition.

See Figure 1. In some cases, the starter cable (1) is routed too near the BAS (2). The resultant electrical interference can cause a false bank angle sensor signal. When diagnosing these issues, verify that the starter cable is routed under the battery box cover.
