SERVICE BULLETIN
Classification:
Reference:

NTB15-085b

April 1, 2016

2013-2015 ALTIMA; CVT DELAYED ENGAGEMENT WHEN SHIFTING INTO DRIVE OR REVERSE

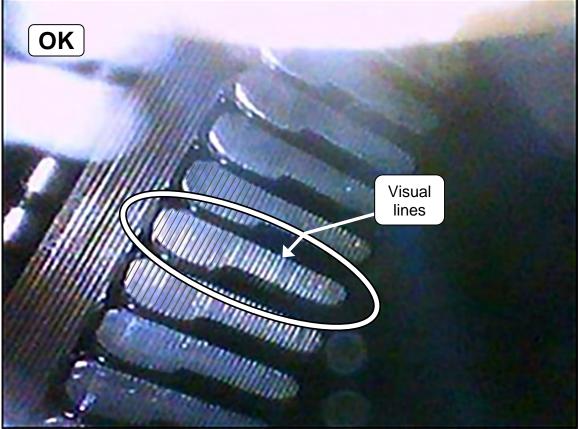
Figure 18: Belt is OK

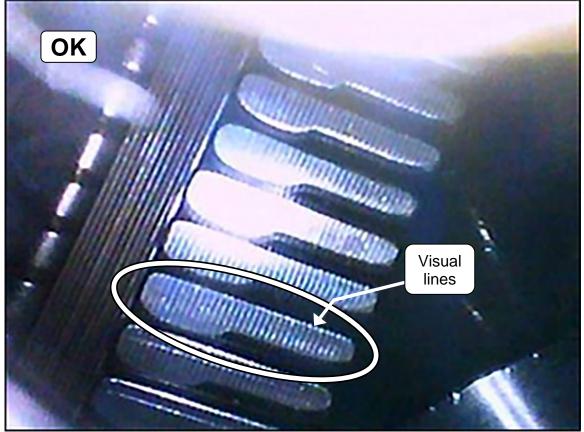
Figure 19: Belt is OK

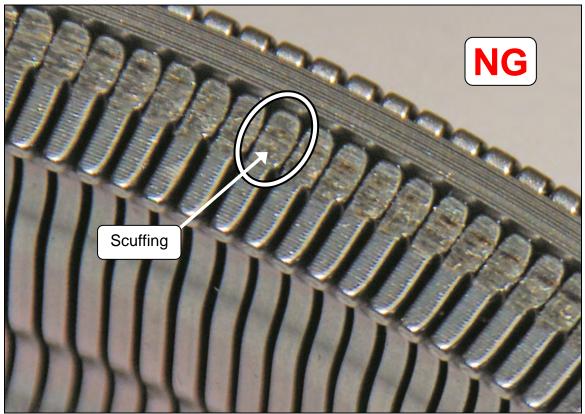
Figure 20: Example of NG belt

- 6. If the belt inspection result is NG, replace the CVT assembly.
 - Get authorization to replace the CVT assembly (see page 26).
 - Make sure to perform step 4e on page 13.

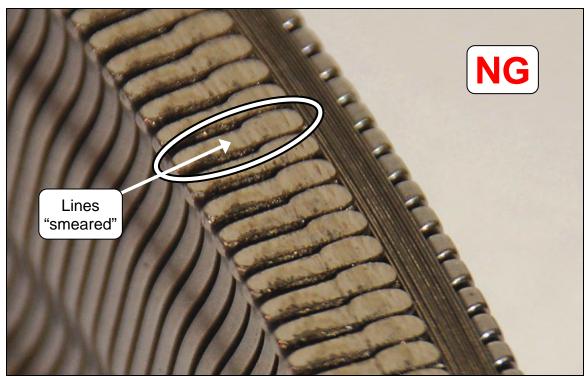
Figure 21: Example of NG belt

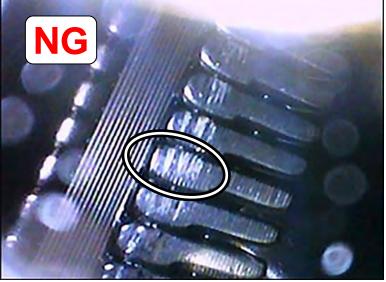
Figure 22: Example of NG belt

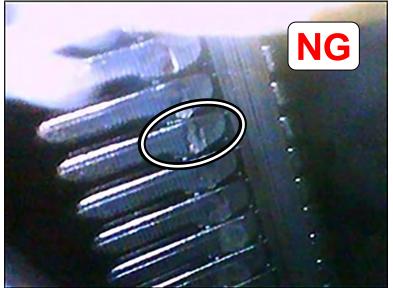
Figure 23: Example of NG belt

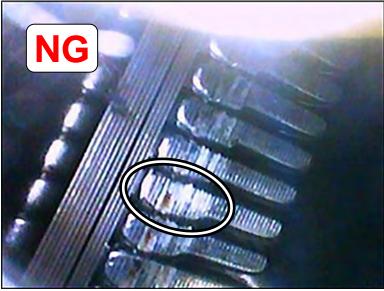
Figure 24: Example of NG belt
