## SERVICE BULLETIN

Classification: EC16-013	Reference: NTB16-037	Date: April 5, 2016
-----------------------------	-------------------------	------------------------

### 2016 TITAN XD; MIL ON WITH ENGINE DTCs STORED

**APPLIED VEHICLES:** 2016 Titan XD (A61)  
**APPLIED ENGINE** Cummins 5.0L V8 Diesel

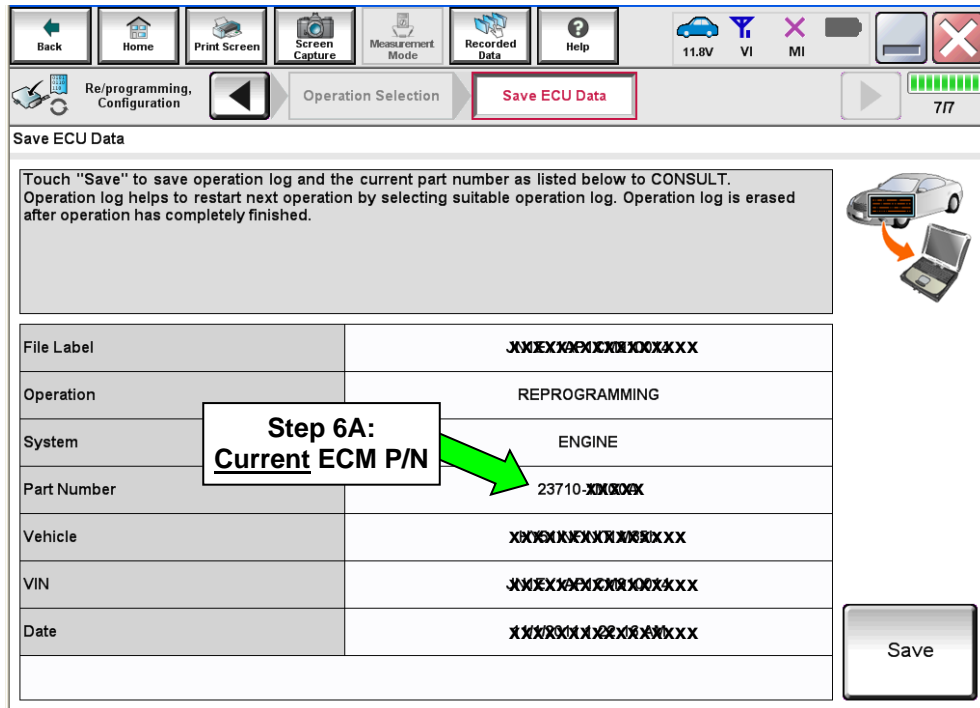
Figure 2

A. Find the ECM **Part Number** and write it on the repair order.

**NOTE:** This is the current ECM Part Number (P/N).

B. Compare the P/N you wrote down to the numbers in the **Current ECM Part Number** column in **Table A** below.

- If there is a match, this bulletin applies. Continue with the reprogramming procedure.
- If there is not a match, this bulletin does not apply. Close C-III plus and refer to ASIST for further diagnostic information.

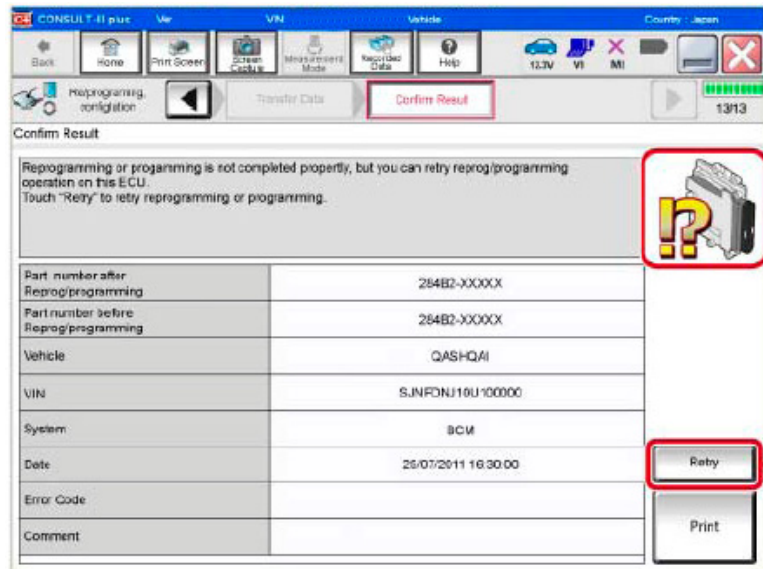
Figure 5

If reprogramming does not complete and the “!?” icon displays as shown in Figure 5:

- Check battery voltage (12.0 - 15.5 V).
- Ignition is ON, engine OFF.
- External Bluetooth® devices are OFF.
- All electrical loads are OFF.
- **Select retry and follow the on screen instructions.**
- “Retry” may not go through on first attempt and can be selected more than once.

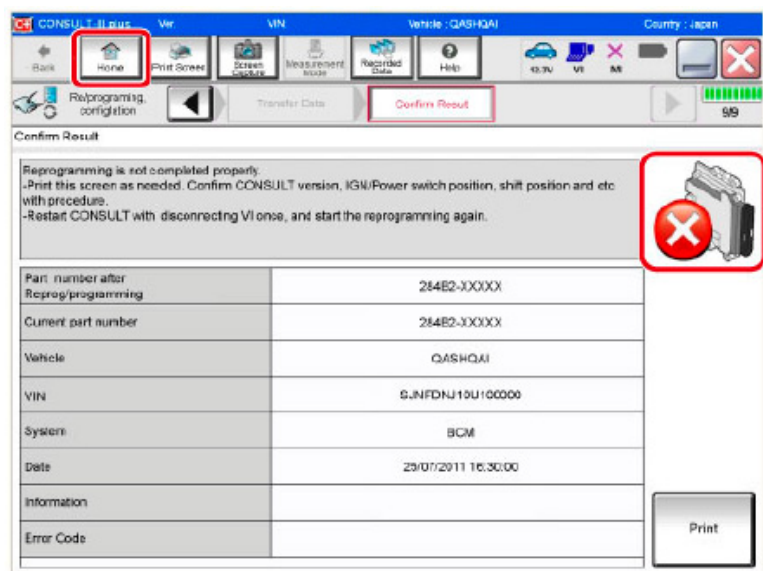
Figure 6

If reprogramming does not complete and the “X” icon displays as shown in Figure 6:

- Check battery voltage (12.0 - 15.5 V).
- CONSULT A/C adapter is plugged in.
- Ignition is ON, engine OFF.
- Transmission is in Park.
- All C-III plus / VI cables are securely connected.
- All C-III plus updates are installed.
- **Select Home, and restart the reprogram procedure from the beginning.**
