April 1, 2016

Subject: Notices, bulletins, customer satisfaction campaigns, consumer advisories and other communications.

On behalf of Tesla Motors, Inc., attached to this cover letter please find the service bulletins issued by Tesla for the month of March 2016.

## Cold Weather Brake Package

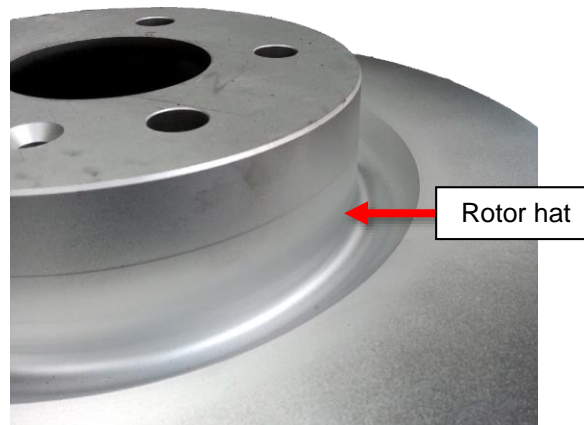
**Figure 3 (No visible rust on hat)**

**NOTE:** Do not replace the rotors unless there is excessive visible rust on the hat.

3. Inspect the part number on the rear rotors:
  - If the part number is 6006431-00-D or later, continue to the next step in this procedure.
  - If the part number is not 6006431-00-D or later and the hat (Figure 3) has excessive visible rust, replace the rear rotors (refer to Service Manual procedure 33010202).

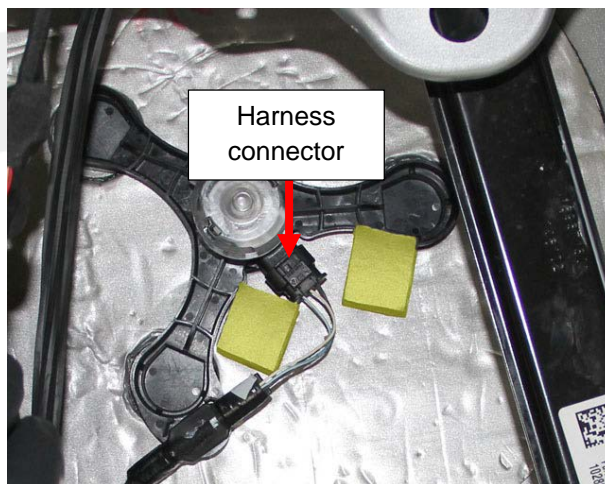
**Figure 1 (Foam tape highlighted)**

On some Model X vehicles, an open rear window might cause the rear door ultrasonic sensors to detect non-existent objects, causing the door to stop unnecessarily while it is opening. The user can still continue to open the door by holding the door switch.

1. Remove the LH rear door closeout panel (refer to Service Manual procedure 11701401).
2. Use alcohol to clean the areas around the sensor carrier. Allow the alcohol to fully dry before continuing.
3. Cut two 2.5 cm pieces of foam tape.
4. Install the 2.5 cm pieces of foam tape on both sides of the sensor harness connector as shown (Figure 1).

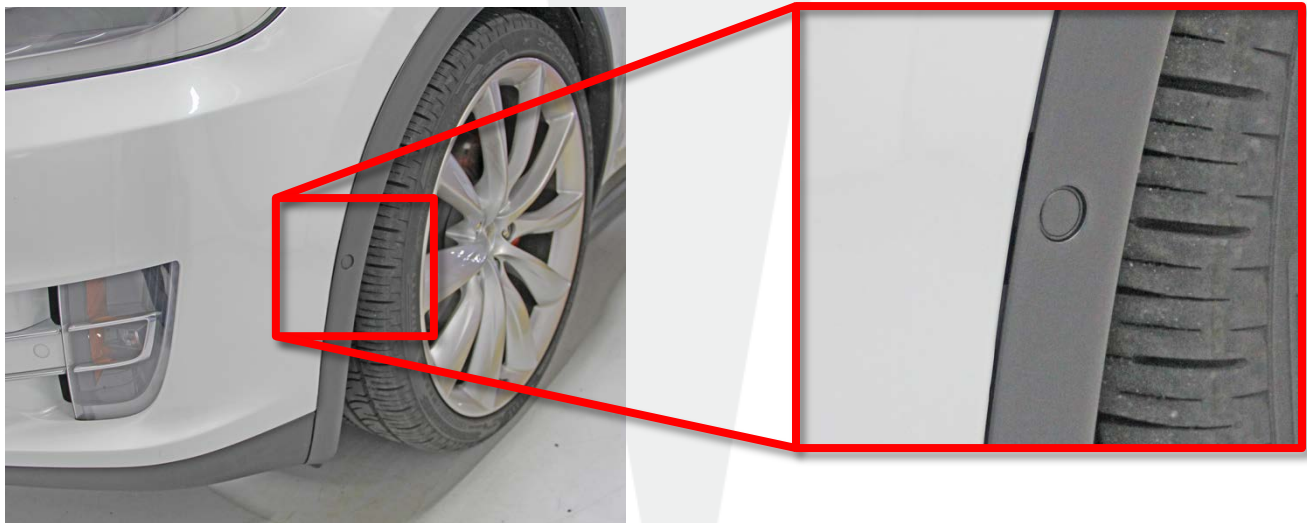
Figure 1

The parking sensors might not be flush with the front fender garnishes (Figure 1) on some Model X vehicles, causing a perceived quality issue.

Upon customer complaint, replace both front fender garnishes.

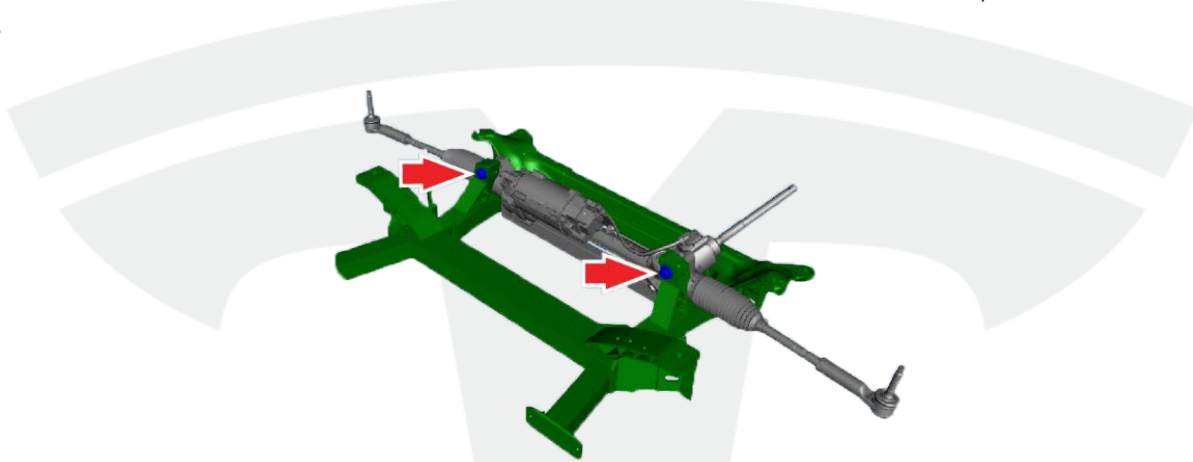
**Figure 1**

Some customers might complain about a clicking sound when turning the steering wheel at low speed, leading to a perceived quality issue.

2. Remove and discard the 2 bolts that secure the steering rack to the subframe (Figure 1).
