## TECHNICAL SERVICE BULLETIN

TSB#: 16-009    Job Code: 9801288    Flat Rate: .4 hr

Add steel plug to furnace to ensure proper operation.

2016 Jay Feather Feather    X23B    G1JB    0301-0303, 0308,0311-0312, 0314-0316, 0321-0324,0328-0329,  
0332, 0344, 0367

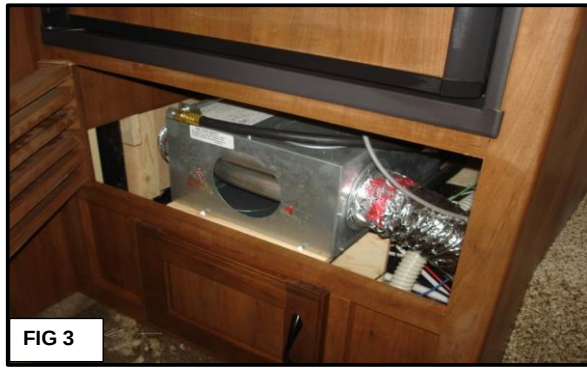
2 **Fig 3:** Shows furnace area where the plug was removed.
