**WB15-55**

DATE :	FEBRUARY 2016	SECTION :	10 - Front axle
EXPIRATION:	FEBRUARY 2018		
SUBJECT :	RADIUS ROD SUPPORT AND I-BEAM AXLE GAP INSPECTION

**WB16-04**

DATE :	FEBRUARY 2016	SECTION :	14 - Steering
EXPIRATION:	FEBRUARY 2018		
SUBJECT :	STEERING DAMPER SECUREMENT

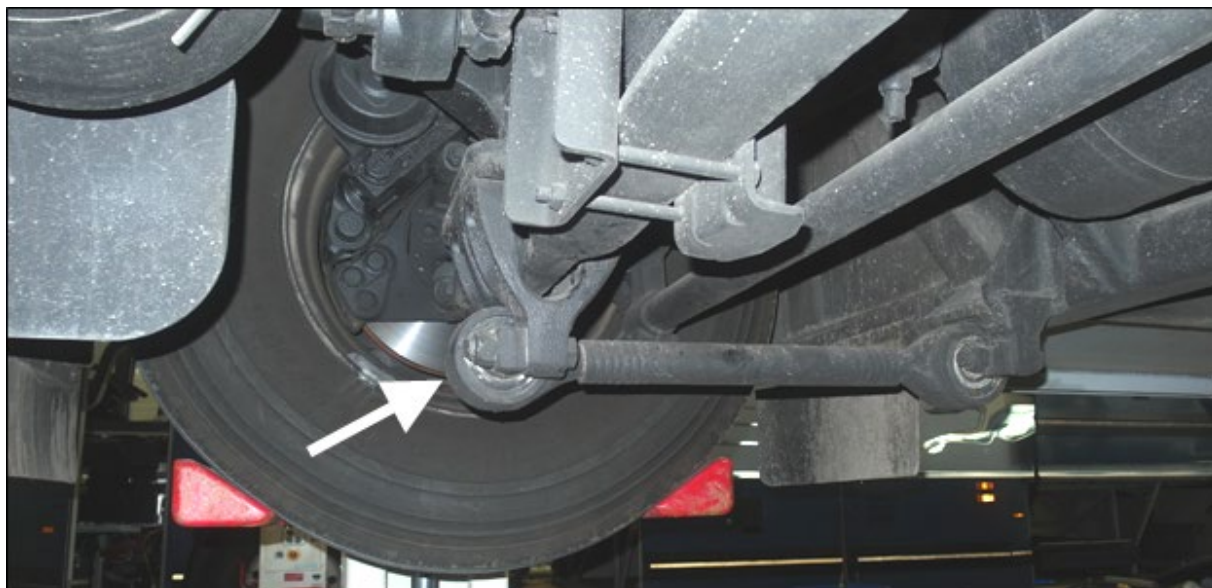
Figure 1

1. Raise the vehicle and find the radius rod supports on the front axle.

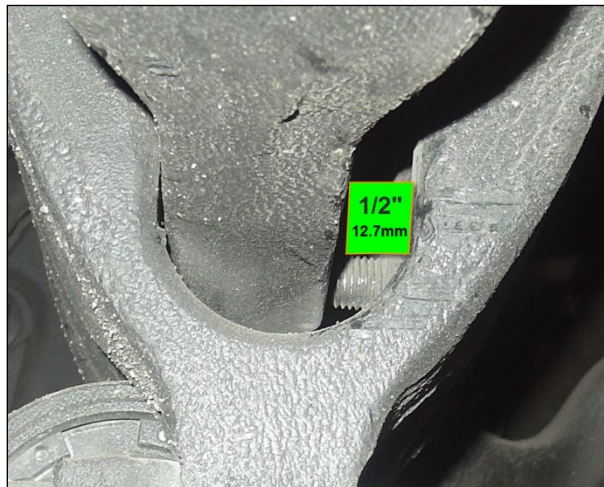
Figure 2

Attempt to insert a shim **12.7 mm** (1/2 in) thick at rear of the axle above the screw between the radial rod support, as shown. (Fig 2.)

**If the shim cannot be inserted** on the left and right support, axle is compliant. *END OF BULLETIN.*

**If the shim can be inserted**, on either one of the supports carry on with next steps.

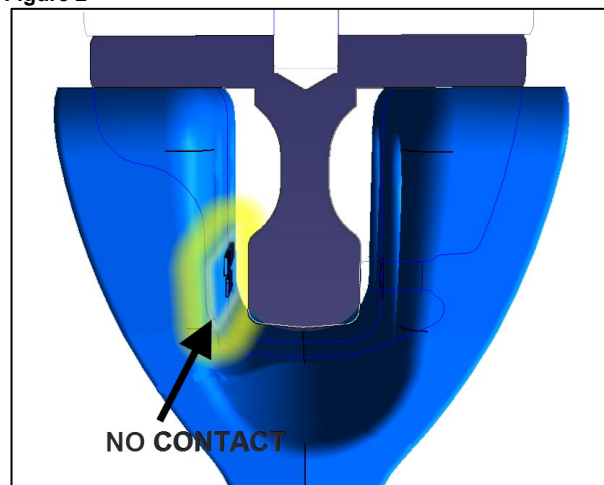
Figure 3

3. Inspect the gap between the axle and the radius rod support on the front.(Fig. 3)
4. After removing debris and protective coating, there must not be contact in zone highlighted in fig. 3.
5. Use a feeler gage set to make sure there is a gap. (Fig.3)

6. If there is contact, skip to **step B.**
7. If there is no contact, remove the set screw in the middle of the support. (A, fig. 4)
8. Replace by a longer set screw, **#5002004** and apply loctite compound **#680038.**
9. Hand-tighten the set screw.
10. Apply a protective coating on affected area. END OF BULLETIN.

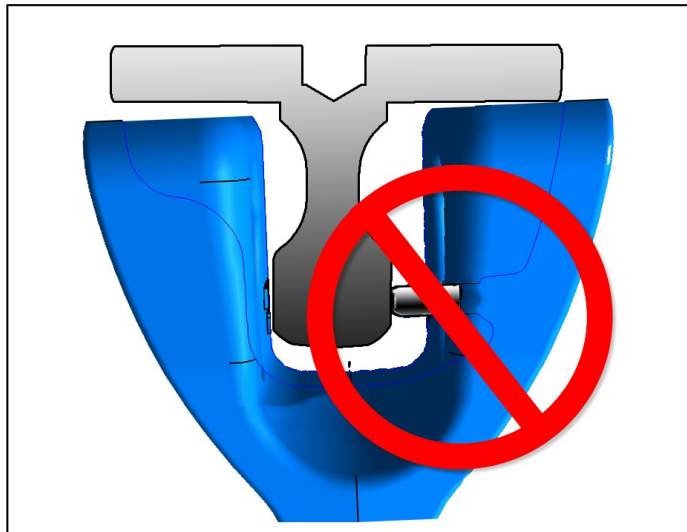
Figure 5

Do not place the support in overhang condition using the set screw as a means to create a gap. (Fig.5)

4. Move the support to try to create a gap. (fig. 3) **Keep the support flat on the axle.**
5. Tighten the bolts and inspect the gap between axle and support.

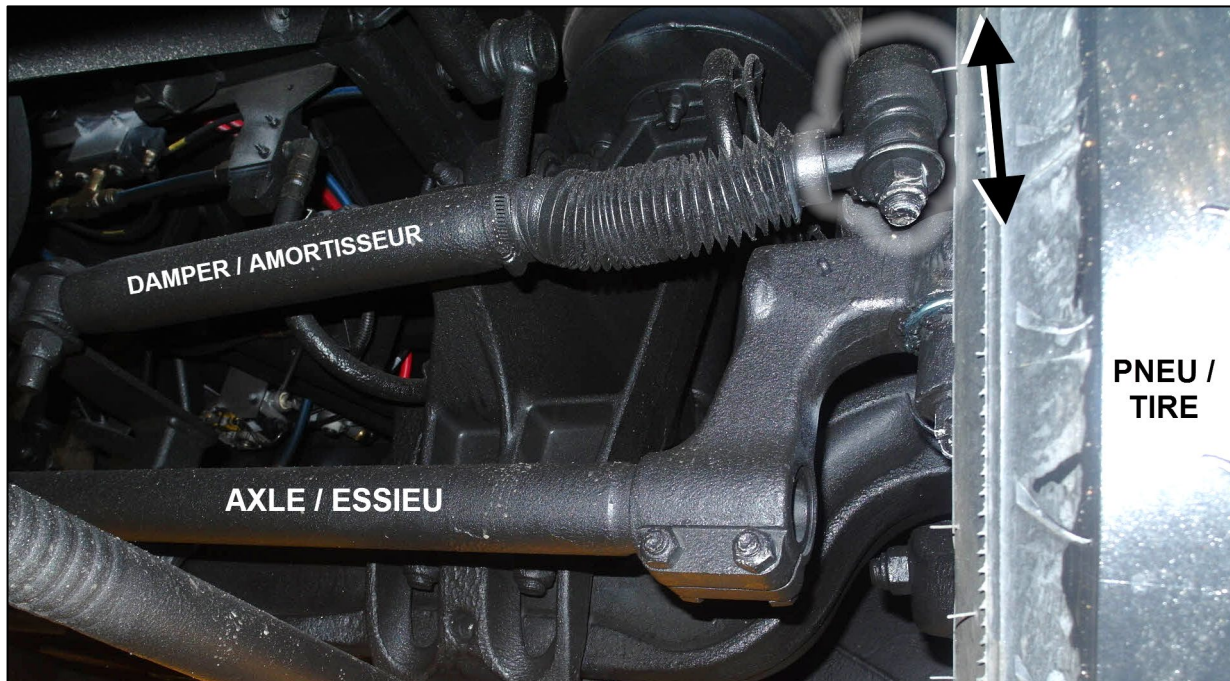
Figure 1

On the vehicles affected by this bulletin the steering damping cylinder rod end spherical bearing may be loose in its housing. Replace as required and secure the steering damper spherical bearing with the provided hardware.

1. Lift vehicle.
2. On front axle the left wheel, locate the steering damper spherical end.(Fig. 1)
3. Make sure there is no vertical play. (Fig. 1)
4. If the spherical bearing moves, replace by a new **660884**.
