## Repair Notice

**216-1**

Missing or unseated C-clip on intermediate steering shaft assembly

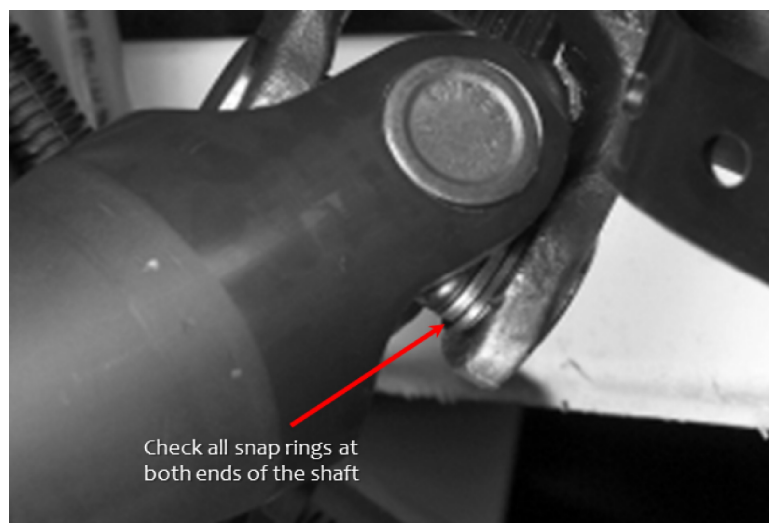
1. Visually inspect the universal joint (u-joint) at each end of the steering shaft for the presence of all four c-clip snap rings
2. Visually inspect for proper seating in the snap ring groove of the u-joint bearing cup

3. If a missing or miss-seated snap ring is found, repair can be performed using the parts in the 5-103X u-joint kit.
