| <b>L624-A.01.16</b> | <b>To: Official After Sales Network</b><br><b>Subject: AC system SW update</b><br><b>Date: March 18,2016</b><br><b>Pages 20</b> | |

Air Conditioning Software Update.

Huracan Coupè.

As a result of continuous product monitoring, Automobili Lamborghini Spa has introduced a new software release to enhance the air conditioning functionality.

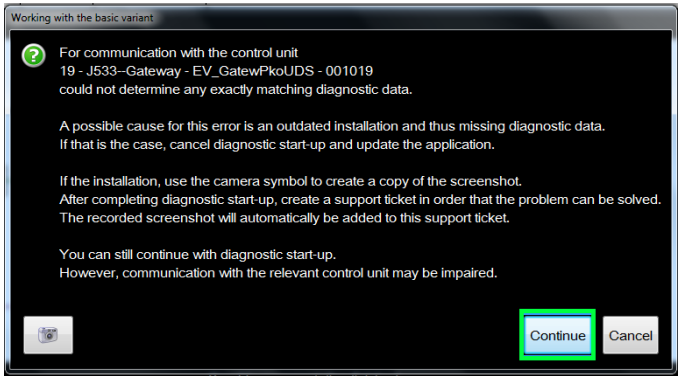
A. If the following dialogue box appears during ECUs identification:

Click “Continue”

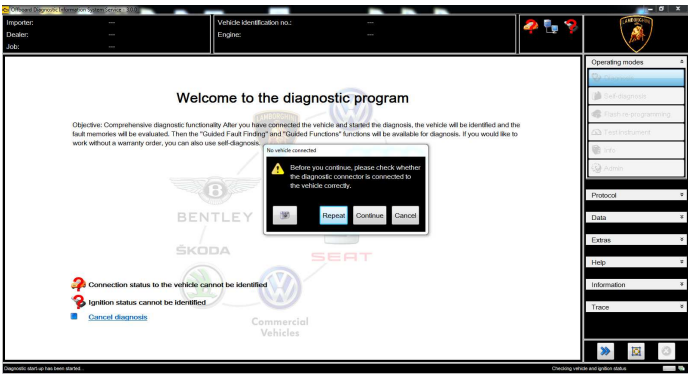
B. If the error message regarding the VAS5054 interface and the two icons for “on board connection” and “key status” are displayed as in the picture below:

- Click “Cancel”;
- Repeat the VAS5054 HW interface installation following the procedure (\*) “VCI Manager v2.0”, by entering in the menu “Extras” on the right side and clicking “Diagnostic interface”.

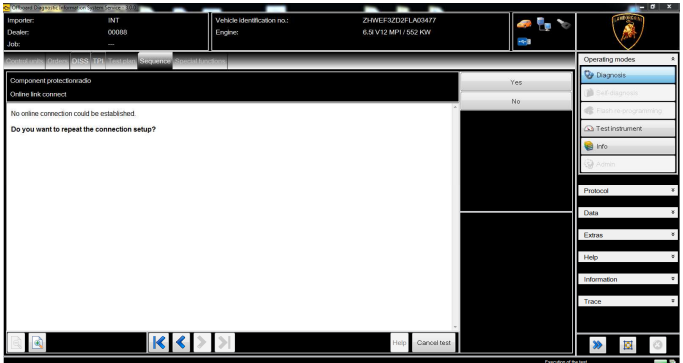
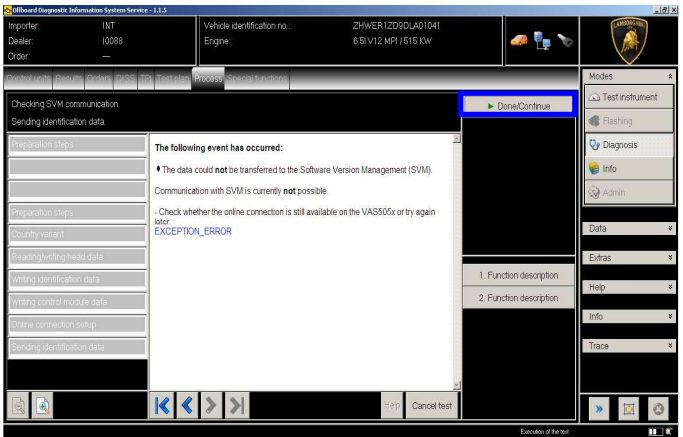
C. If one of the connection error screens is shown as in the pictures below:

- it is not possible to establish a connection with the central server. Please check carefully that the diagnosis laptop is properly connected to the internet network and retry clicking “Yes” or “Done/Continue”.

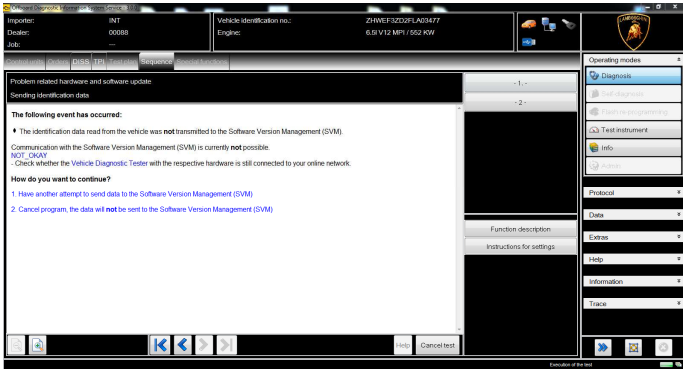
D. If the loss of connection happens during the target/actual comparison during SVM procedure:

- It is not possible to connect to central server, check the working connection of internet and retry clicking “1”.

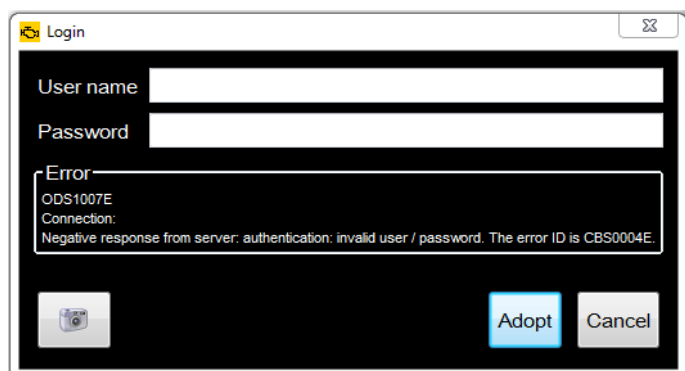
E. If the incorrect identification message is shown as in the picture below (error code: ODS1007E):

- be sure that your Geko account is valid;
- be sure that the label “Geko” is written on the token that you are using for the authentication;
- be sure the Password inserted is correct;
- click “Cancel” and perform the application test (see document “ODIS\_Checking\_ConnectionServer\_SVM\_2.0” (\*)).
