Eliminating Noise Symptoms - Replacing Rubber Stops on Front Hood (Creaking noise from around the dashboard or A-pillar/SY0116)

Vehicle type: **Macan (95B)**

Model Year: **As of 2014 up to 2016**

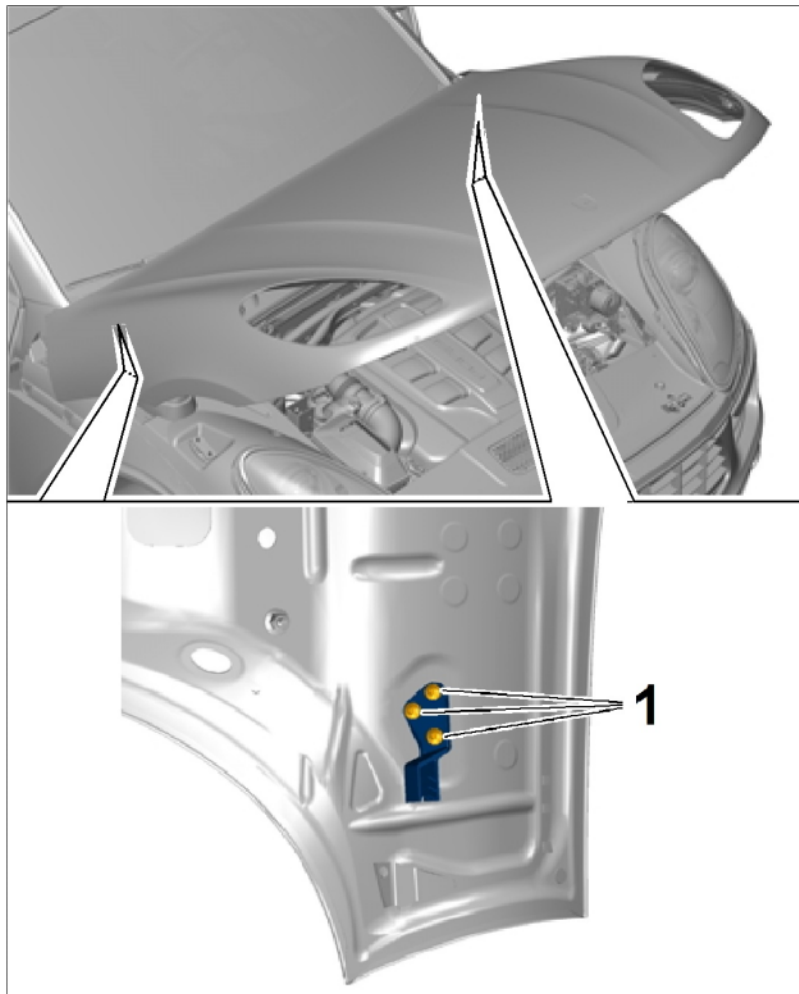
Symptom: Creaking noises come from around the dashboard/A-pillar while driving.

Cause: Material pairing between the buffers and rear rubber stops on the front hood results in creaking noises from around the dashboard/A-pillar at the left and right.

Remedial action: In the event of a complaint, replace both rear rubber stops on the front hood with new rubber stops ⇒ *Workshop Manual '552237 Disassembling and assembling front lid'*.

Replacing rear rubber stops

Tools and Materials: **95B.863.237.A NEW** ⇒ Rubber stop, left
95B.863.238.A NEW ⇒ Rubber stop, right
