SIL 618

# Service Information Letter

Units Affected: DLB, DMB, and D2000B, D3000B, D4000B Series Derricks  
equipped with Radio Controls (see attached list)

## Control Module Update

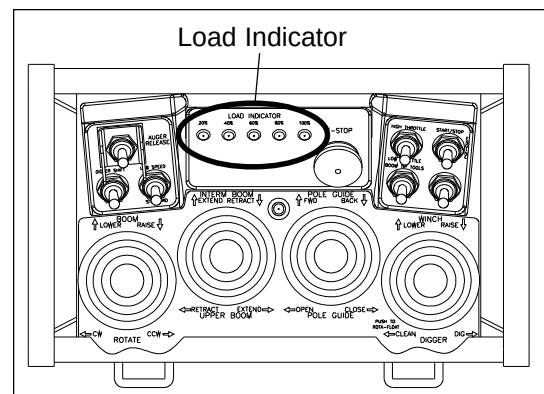
**Figure 1 — Typical Radio Control  
With Load Indicator**

Digger derricks using radio controls with load indicators (refer to Figure 1) have been found to sometimes allow the digger and the winch to operate at the same time possibly causing damage to one or both functions. A change has been made to the radio control module which eliminates the possibility of the two functions working together.
