## Technical Information Bulletin

### The Intake Throttle Valve Is Causing Regeneration Issues on Certain On-Highway Truck Engines {1000, 1087, 7000}

Media Number -M0069062-00

CT660S (S/N: TGA1-UP; TGD1-UP; TRK1-UP; TKL1-UP; TGR1-UP; TGS1-UP; TJS1-UP; TGT1-UP; TGW1-UP; TSW1-UP; TSY1-UP; TGZ1-UP)

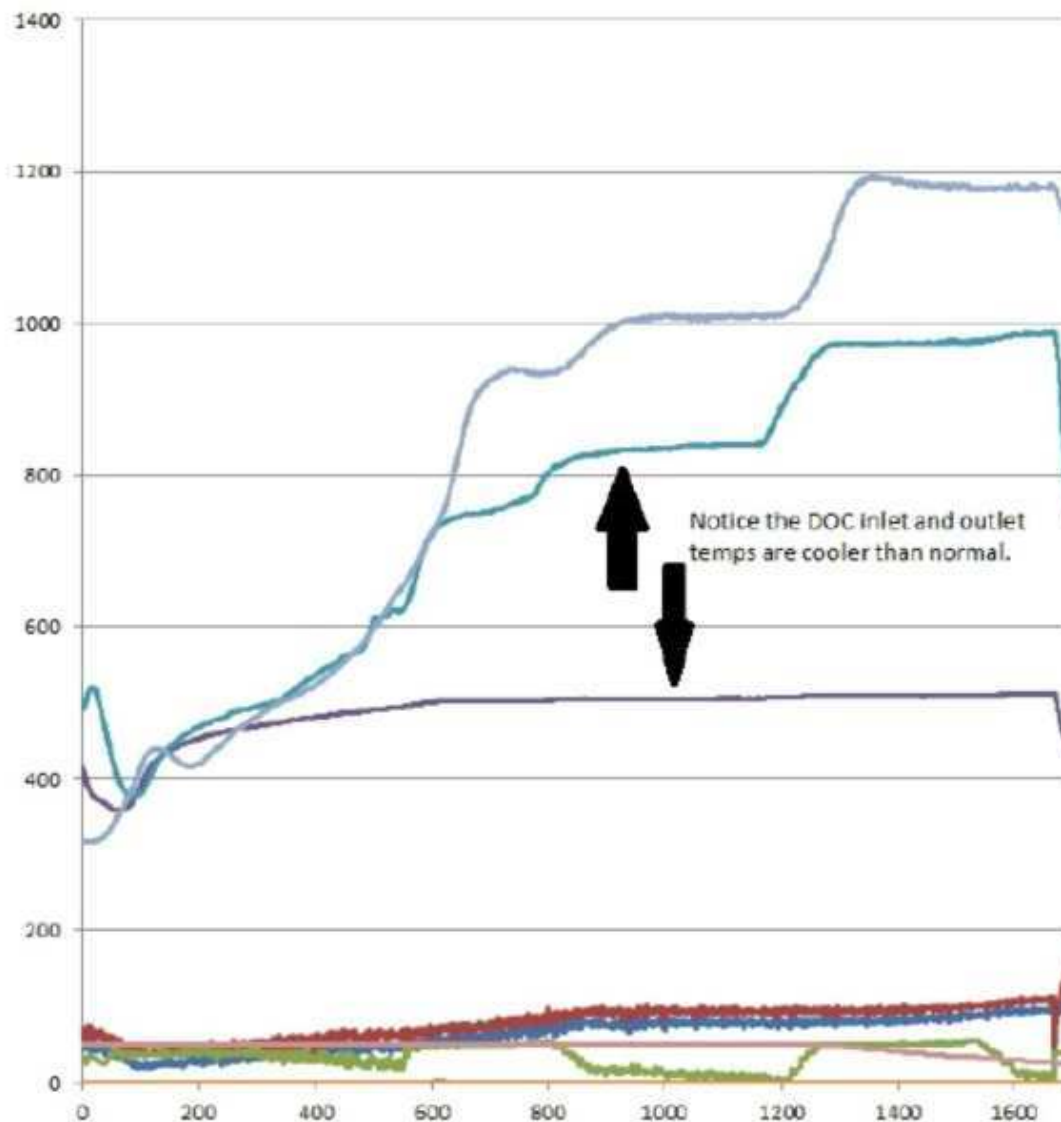
Illustration 1

OBFCT with a Bad ETV

**Item 1:** Notice that the DOC inlet and outlet temperatures are cooler than normal regeneration should be. The DOC inlet should be in the 288° C (550° F) to 371° (700° F) range. This is due to the ITV not working properly to produce enough heat in the exhaust system.

**Item 2:** Notice the length of time it takes for the temps to start rising.

1. Replace the ITV and rerun the OBFCT to verify the repair.

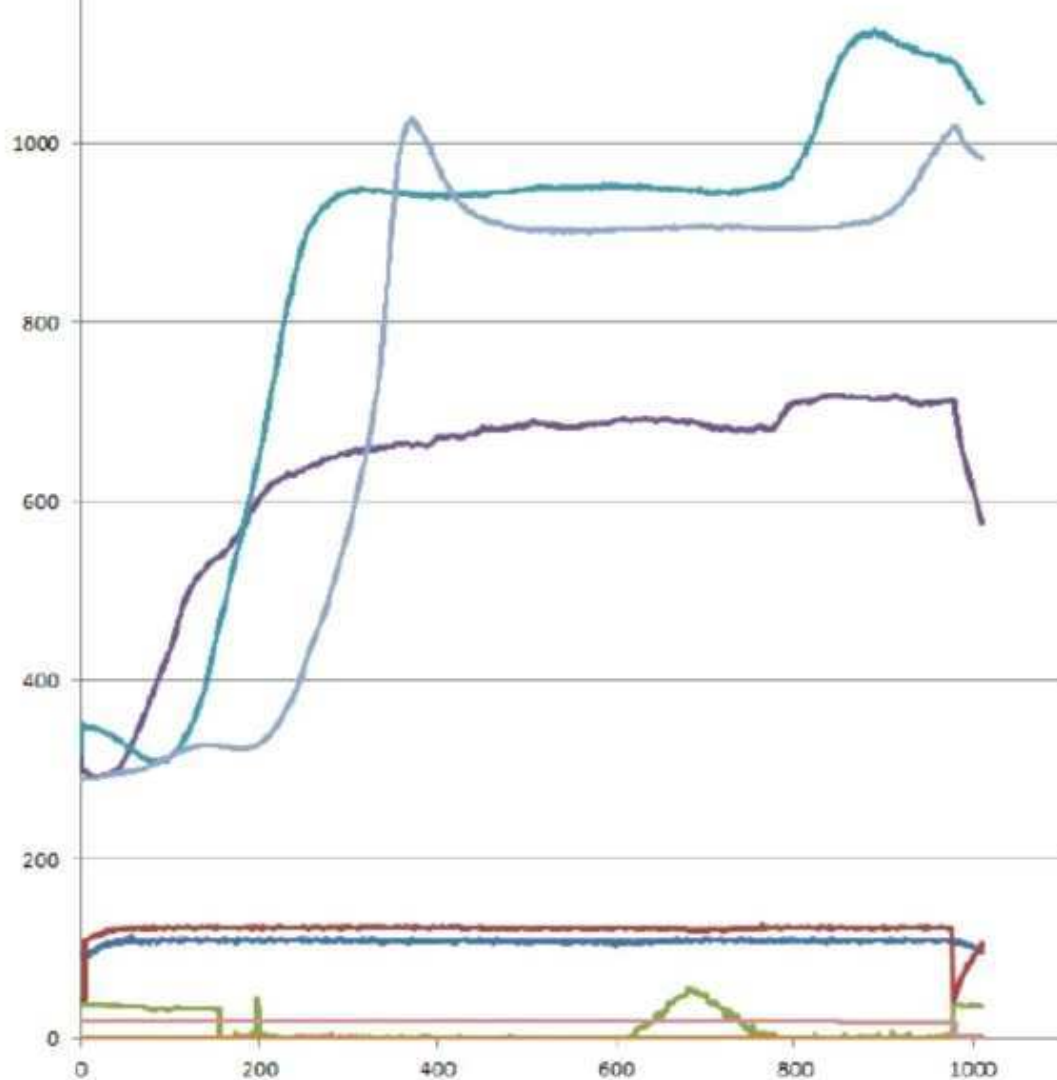
Illustration 2

#### Good Regeneration Chart

**Item 1:** Notice the temperatures rise much quicker than the bad regeneration shows.

**Item 2:** DOC inlet temperature is in a good range.
