**Service Information Bulletin**

| SUBJECT | DATE |
|---|---|
| SPN 4765 (MCM) (GHG17) | February 2016 |

## 2 SPN 4765/FMI 0 - GHG17

Exhaust Temperature High

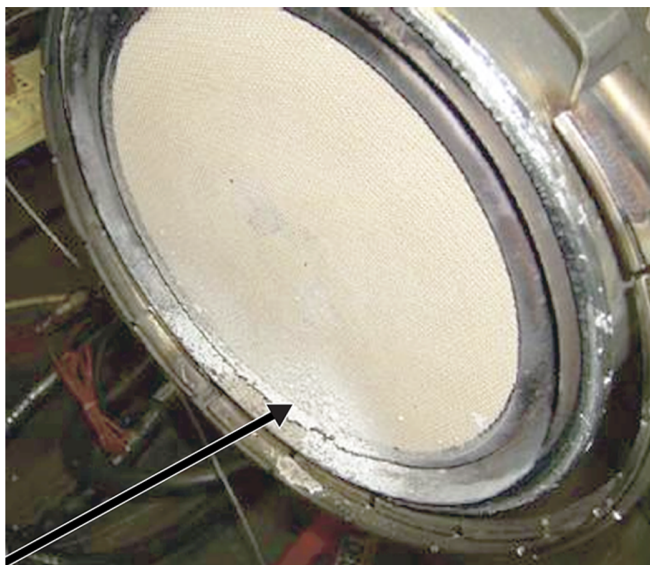
d140015

14. Was coolant contamination found (white residue on inlet face of the DPF and a sweet smell from exhaust)?
- Yes; Go to step 17.
  - No; Go to step 15.

19. Repair the cause of coolant entry as necessary and Go to step 23.
20. Question the operator about excessive oil consumption. Possible causes of excessive oil consumption are:
