## ROADSTER 2015 Product Reference Article - 108572

Up-to-date technical information on the 2015 Roadster product. Destined for dealer service department staff.  
This document may change without notice, always consult the latest version available.

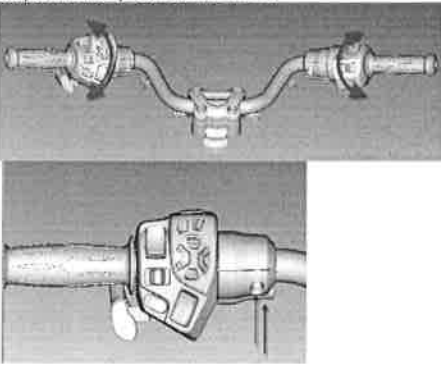
| 2015 | F3 | Handlebar comodo movement - clamp not torqued enough | No Case needed | On a few F3 units the handlebar comodo (multi-function switches) may rotate, this is due to the handlebar end clamp not being fully torqued. Simply torque the clamp bolts to 11 ±1 Nm.<br> | | 11-02-2015 |
