## Noise from air deflectors between vent and outer air duct on 222 and 205/253

| Topic number | LI68.10-P-058924 |
| Design group | 68.10 Instrument panel |
| Validity | BR222 and BR205/253 |

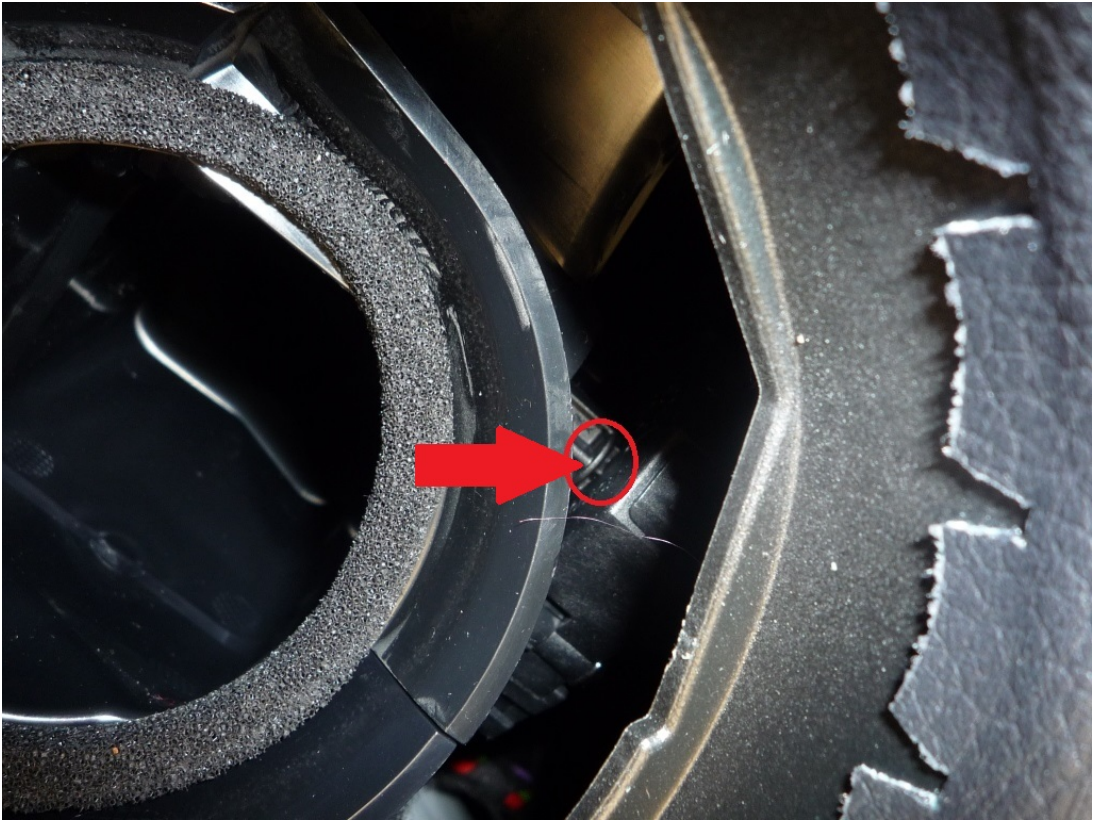
Bild1.JPG:

The air deflectors at the side may generate cracking/grunting noise.

Shaft movement may cause friction noise between the shaft and the housing

| Attachments | |
|---|---|
| Bild1.JPG | Apply lubricant in marked area (BR222) |

1. Remove side ventilation nozzles.
2. Apply special lubricant, with extended attachment (Picture 2), liberally in gap between eddy and shaft (Picture 1: BR222, Picture 3 BR205/253).
3. Following liberal application of lubricant run a function test.

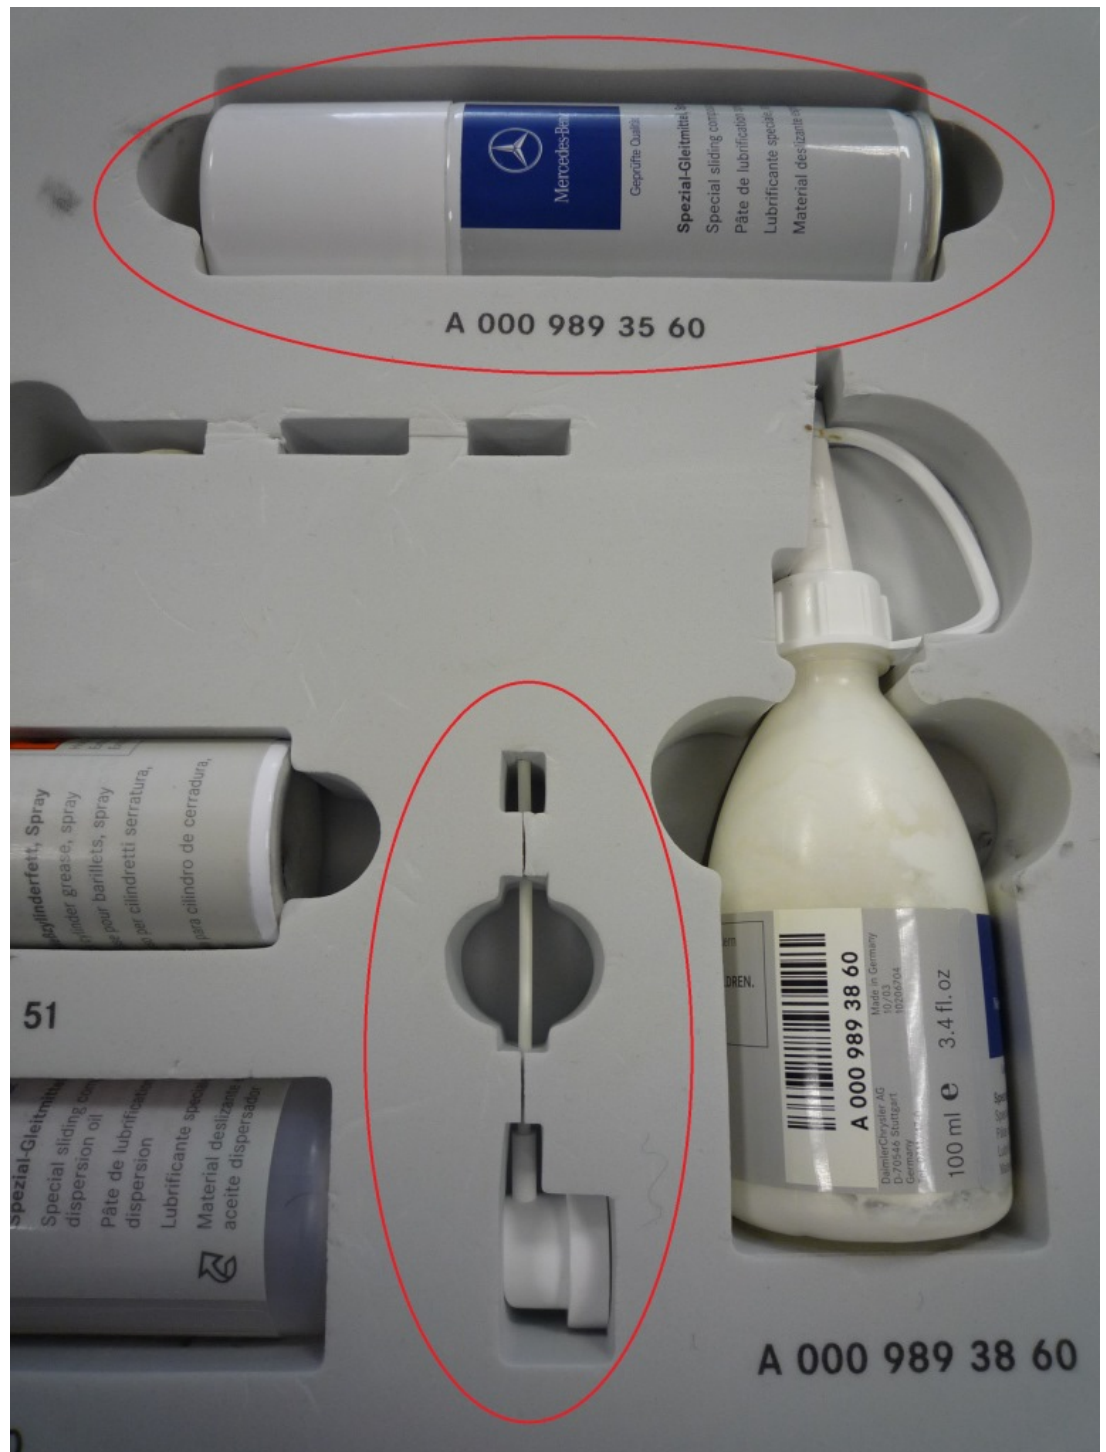
Bild2.JPG:

| File | Description |
|---|---|
| Bild2.JPG | Select extended attachment for lubricant |

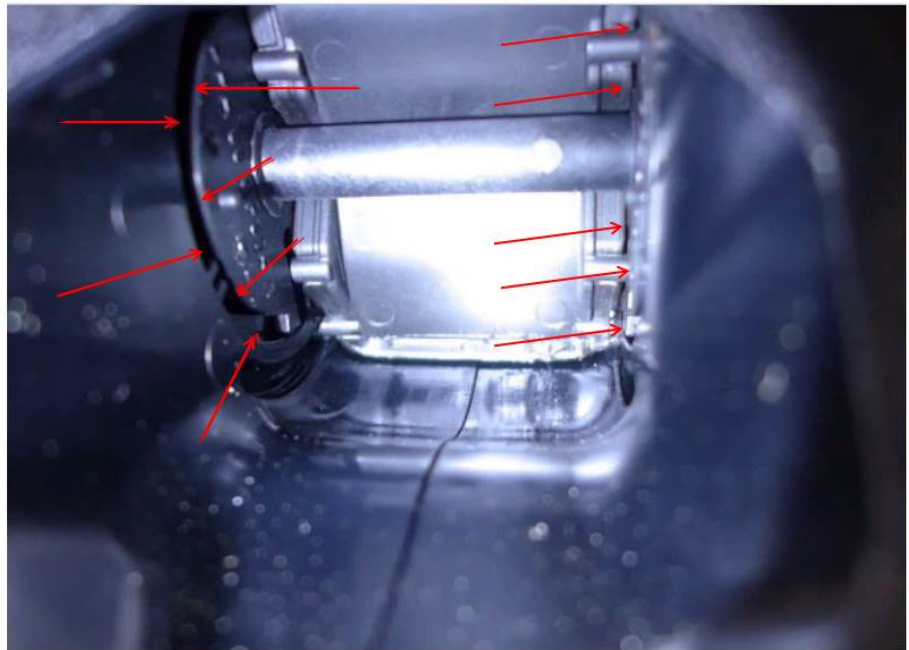
Bild 3.JPG:

| Attachments | |
|---|---|
| Bild 3.JPG | Apply lubricant to marked area (BR205/253) |

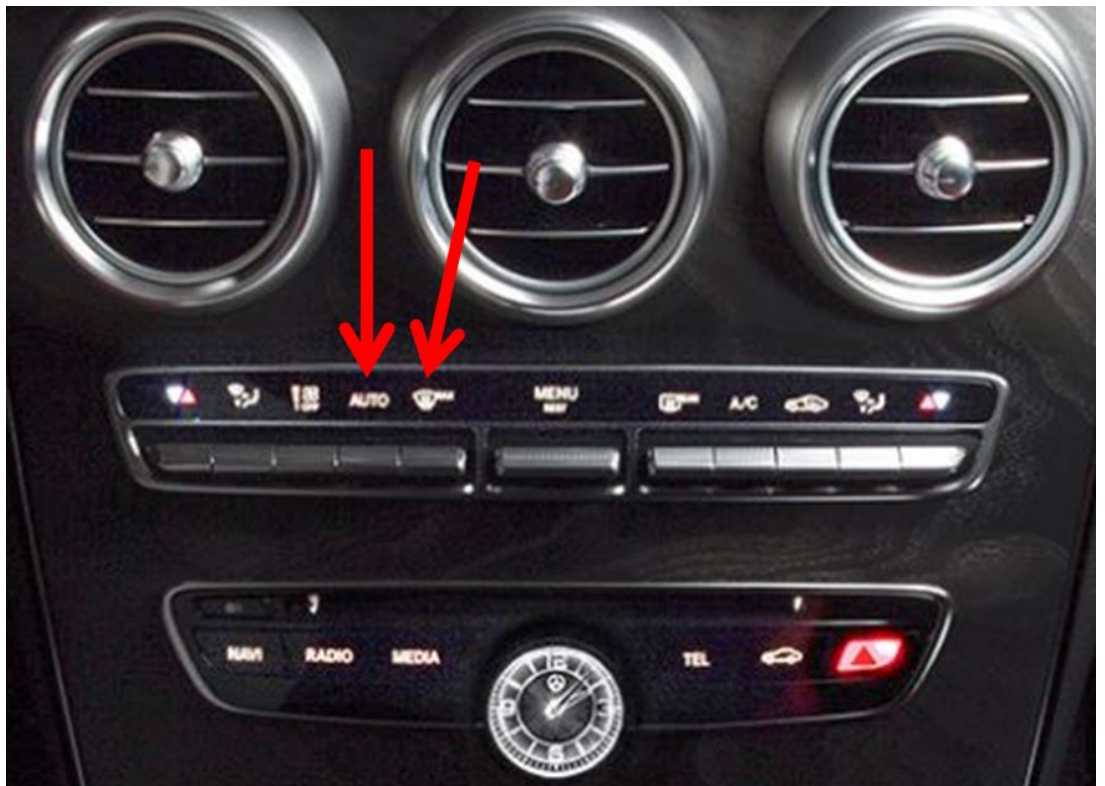
Bild4.JPG:

| Attachments | |
|---|---|
| Bild4.JPG | Switch to be operated |

Several complete flap operations must be made to ensure that the lubricant is uniformly distributed. To do so, operate windshield defroster and automatic system on operating unit alternately (Picture 4).
