## Wind noise on driver door, rear door when sliding roof in tilt position

| Topic number | LI72.00-P-064122 |
| Validity | MODEL 213 |

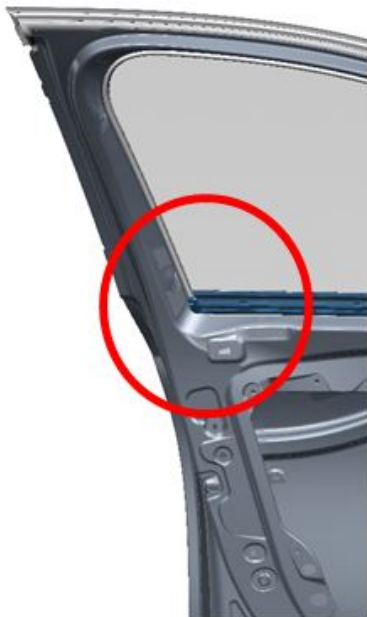
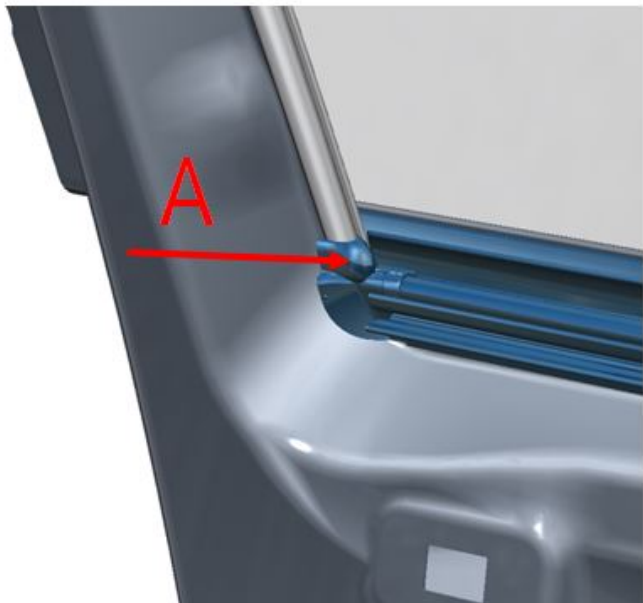
Bild 1.JPG:

Air entry due to vacuum created by sunroof being in open/tilt position.

The fit of the molded corner on the inner dust shield seal on the front door B-pillar or the rear door on the window divider (see picture 1) may be too far forward
