TO: Mercedes-Benz Dealer Principals, General Managers, Sales Managers, Service Managers, Parts Managers	FROM: Thomas Brunner, Department Manager, Vehicle Compliance and Analysis, Engineering Services
RE: <b>Service Campaign 2016040003</b> <b>Model 190, AMG GT-S Model Year 2016</b> <b>Check Both Rear Axle Upper Control Arms,</b> <b>Replace if Necessary</b>	DATE: August 5, 2016

Campaign No. 2016040003, August 2016

SUBJECT: **Model 190, Model Year 2016**  
**Check Both Rear Axle Upper Control Arms, Replace if Necessary**

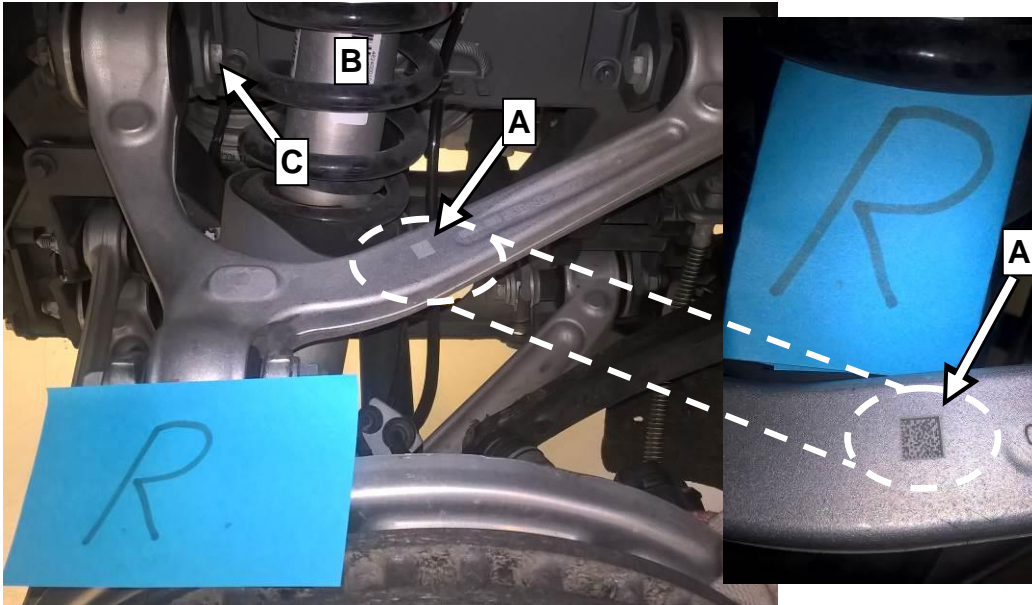
Remove rear wheels.
2. Take a picture of the QR code sticker (A, Figure 1) on the upper rear axle control arms:
  - Clearly mark control arm installation location (R for right, L for left) in the pictures as shown.
  - Clean QR code with rag without solvent.
  - Refer to Figure 1 for example of photograph of right rear upper control arm.
