TO: Mercedes-Benz Dealer Principals, General Managers, Sales Managers, Service Managers, Parts Managers	FROM: Thomas Brunner, Department Manager, Vehicle Compliance and Analysis, Engineering Services
RE: Service Campaign 2016070009 Models 166, 292. Model Year 2016 Correct Torque of Front Left and Right Torsion (Stabilizer) Bar Linkage Nut	DATE: August 19, 2016

Campaign No. 2016070009, August 2016

SUBJECT: **Models 166, 292; Model Year 2016**
Correct Torque of Front Left and Right Torsion (Stabilizer) Bar Linkage Nut

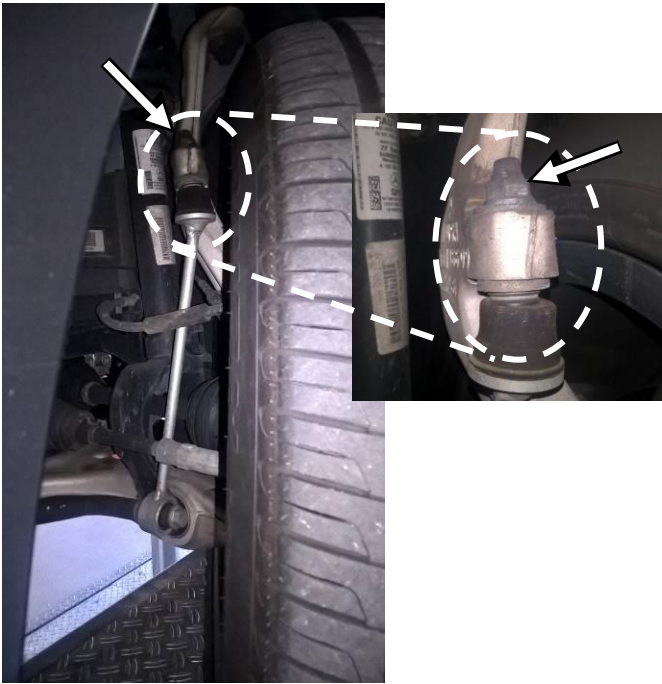
Figure 1

Daimler AG, the manufacturer of Mercedes-Benz vehicles, has determined that on certain GLE Class vehicles (166, 292 platform), the torque of the front left and right torsion (stabilizer) bar linkage nut to the steering knuckle does not correspond to current production specifications. An authorized Mercedes-Benz dealer will check and correct the torque.

Linkage nut (arrows, Figure 1) is located at bottom of steering knuckle.

1. Drive vehicle onto vehicle lift and raise.
2. **Nm** Torque front left and right torsion (stabilizer) bar linkage nut (arrows, Figure 1) to: 65 Nm.
