## Map pocket on front seat backrest trim does not close

Topic number	LI91.10-P-063347
Version	5
Design group	91.10 Front seats
Date	11-21-2016
Validity	Model series 222 as of start of production (SOP) up to WDD2220331A233180 (October 2015) Model series 217 as of SOP up to October 2015 Model series 205 with SA code 30P as of SOP up to April 2016
Reason for change	Damage codes expanded and model designations adjusted
Reason for block

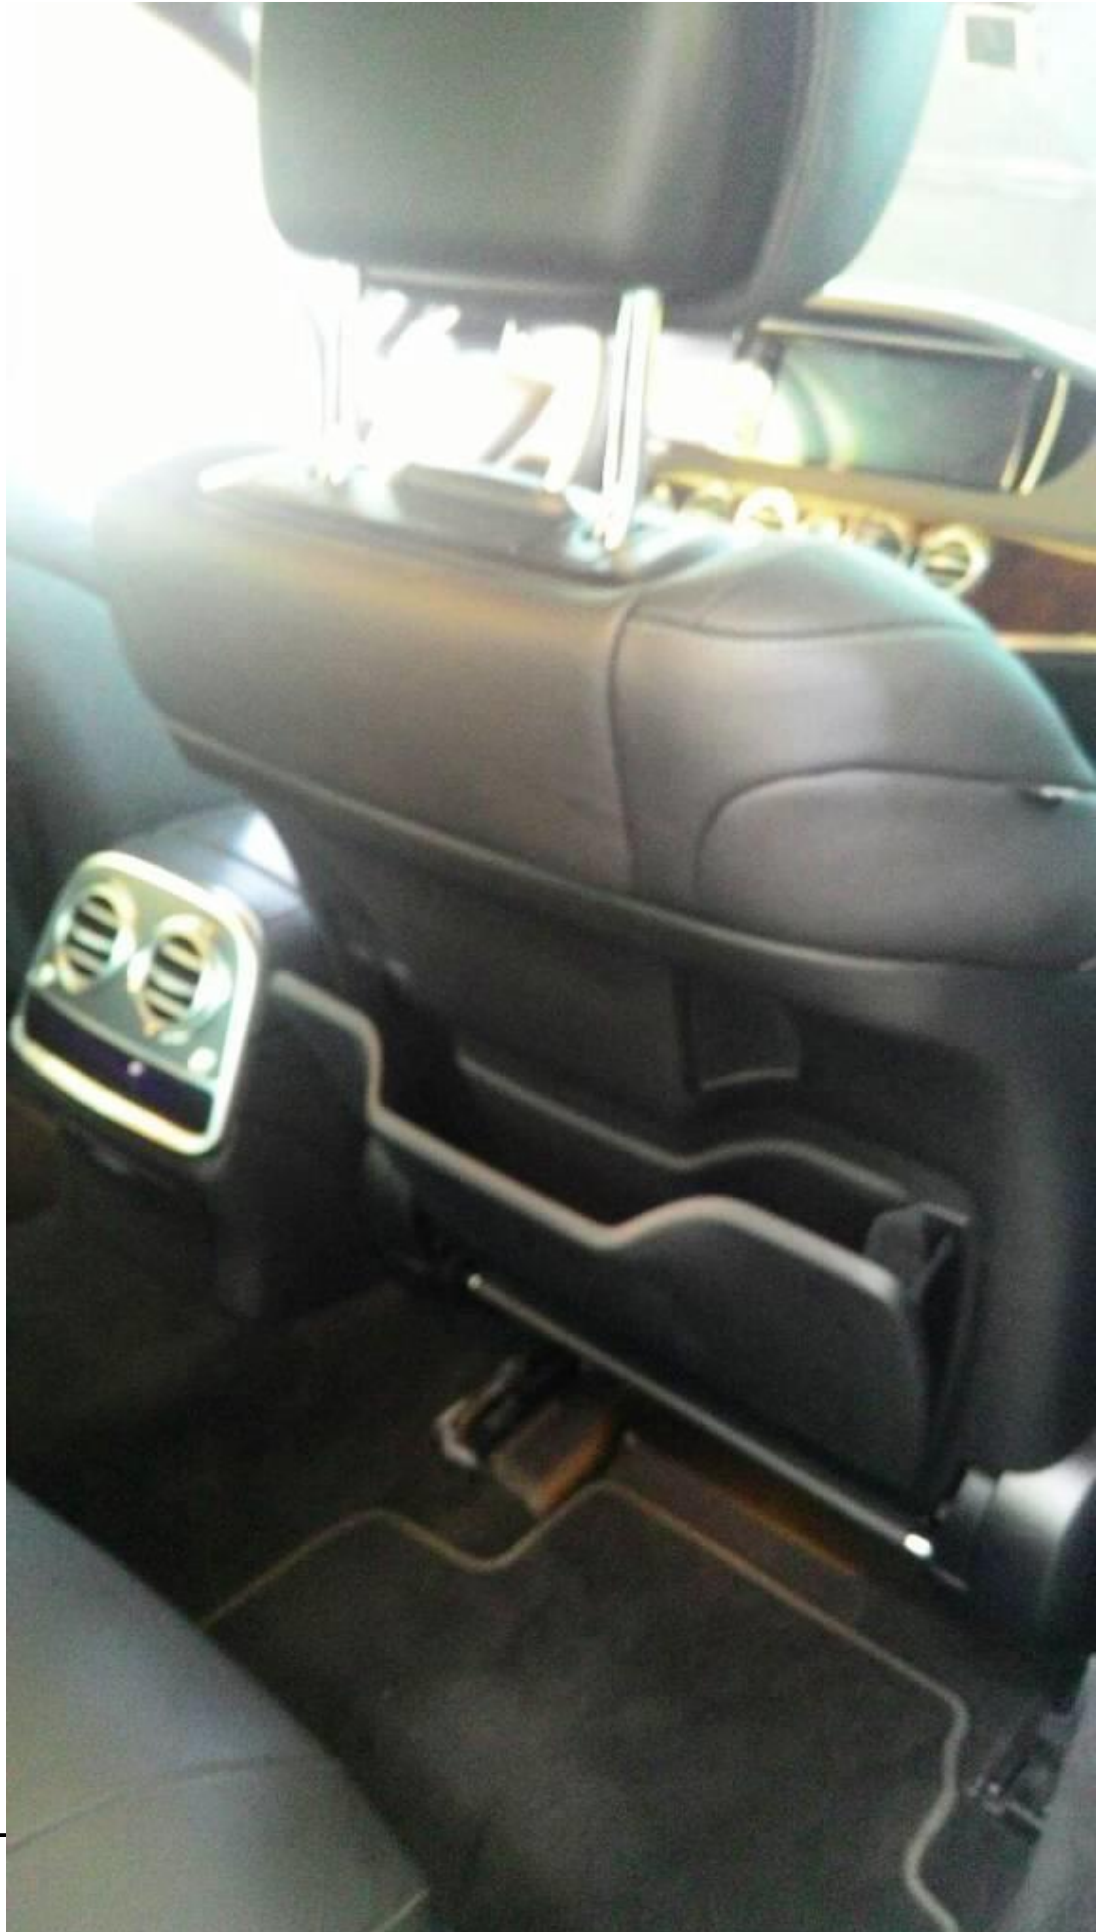
Pic. 1.jpg:

The tensioning strap for the map pocket on the front seat backrest trim does not have any tension, so the map pocket no longer closes by itself.

Attachments	
File	Description
Pic. 1.jpg	Map pocket no longer closes

Loss of tension may be caused by embrittlement of elastic band because of high heat levels in the vehicle.

Replacement of affected backrest trim.
