## PRE-SAFE Impulse Side

| Topic number | LI91.60-P-064763 |
| Design group | 91.60 Airbag, pedestrian protection |

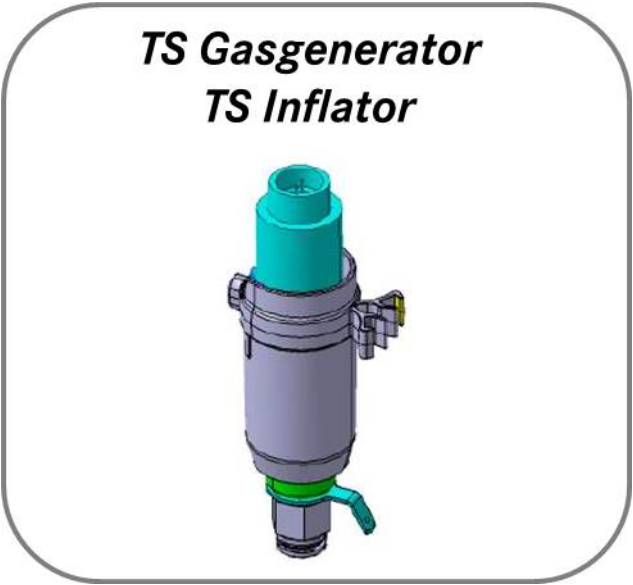
TS Gasgenerator (pic.1)  
.jpg:

| File | Description |
|---|---|
| TS Gasgenerator (pic.1).jpg | Gas generator parts kit |

- 1) Gas generator parts kit in the relevant seat backrest (driver or passenger side) (pic 1)
- 2) 2x short range radar sensors in the front bumper (left and right)

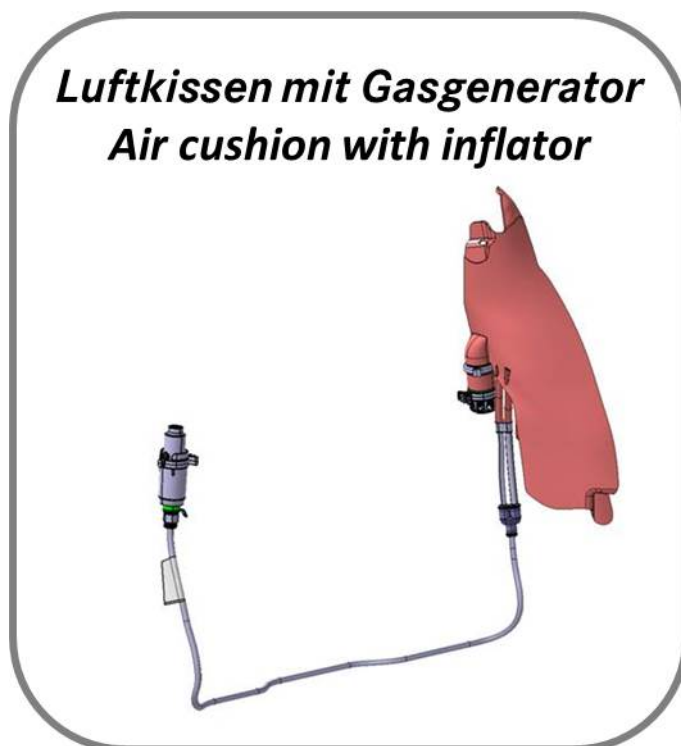
Luftkissen mit Gasgenerator (pic. 3).jpg:

| File | Description |
|---|---|
| Luftkissen mit Gasgenerator (pic. 3).jpg | Air cushion with gas generator |

After triggering of the sidebag (e.g. after a crash), it is always necessary to replace the "PRE-SAFE ® Impulse Side" components (air cushion with gas generator) (pic 3).
