# Technical Journal

**Headlamp, abnormal moisture/water leakage**

REF NO:  
**TJ 25705**

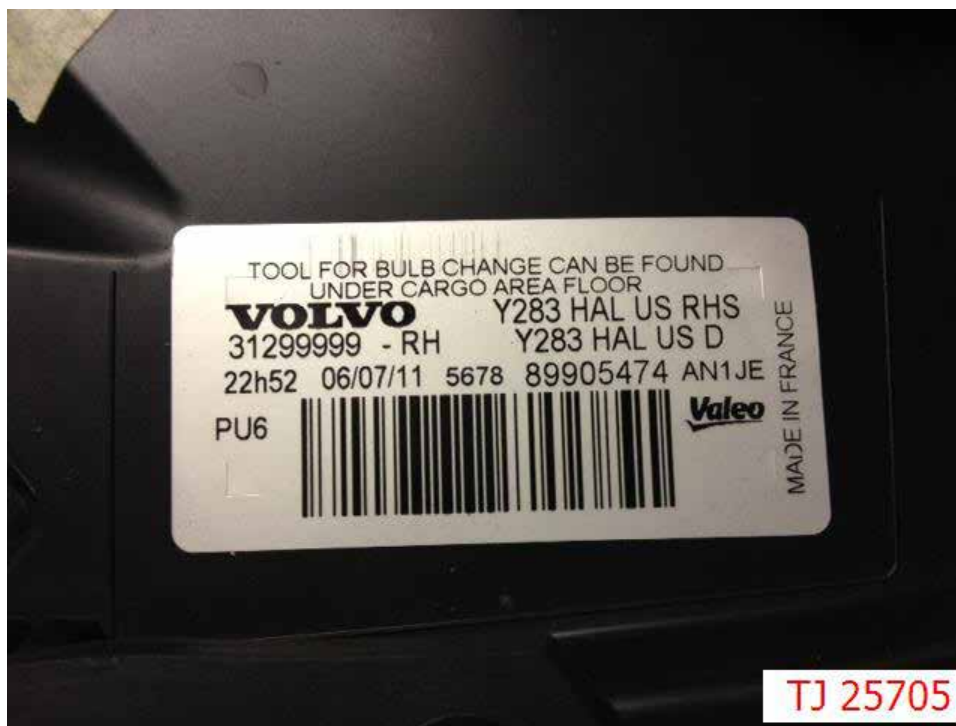
| File Name | File Size |
|---|---|
| TJ25705.JPG | 0.0323 MB |

Only if the symptom occurs after breakpoint 2011w39. Use concern area "Vehicle Report" and sub concern area "Support Not Needed". Add a photo of the production label on the headlamp, see attachment TJ25705.jpg.
