Service Bulletin

MAZDA

Subject: POPPING AND/OR SQUEAKING NOISE FROM FRONT SHOCK ABSORBER AND/OR CREAKING NOISE FROM FRONT LOWER ARM BUSHING	Bulletin No: 02-001/16
	Last Issued: 02/23/2016

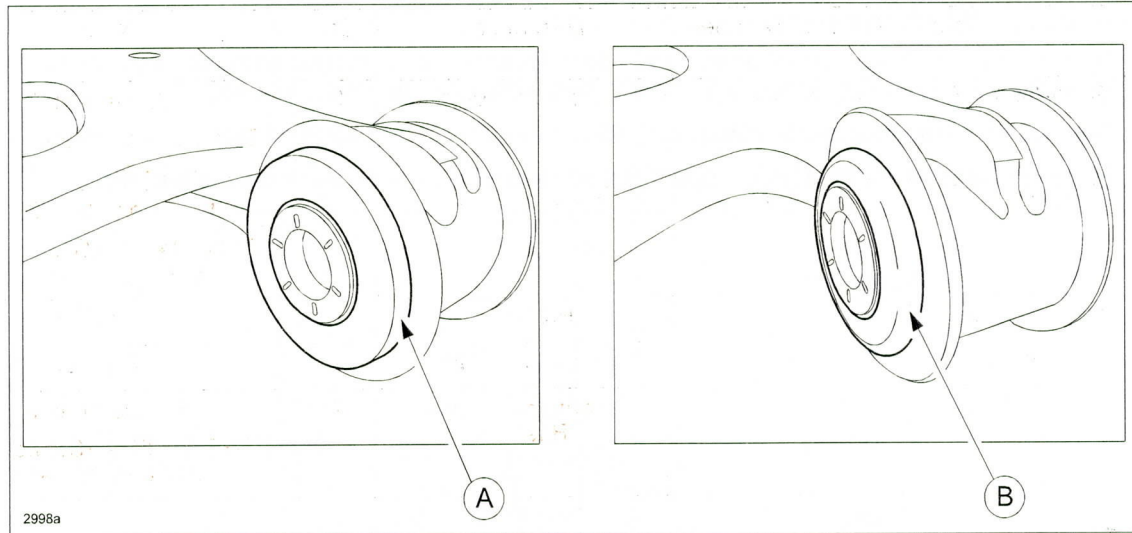
CAUTION: Make sure the bushing has been properly inserted by verifying that the bushing tab **IS FULLY EXPANDED**, as shown in the illustration to the left (A). The illustration to the right (B) shows an example of a bushing tab that **IS NOT FULLY EXPANDED**.
