Subject: <p style="text-align: center;">STAINS APPEAR ON WHEELS</p>	Bulletin No: 02-002/16
	Last Issued: 01/08/2016

Subject: POPPING AND/OR SQUEAKING NOISE FROM FRONT SHOCK ABSORBER	Bulletin No: 02-001/16
	Last Issued: 1/8/2016

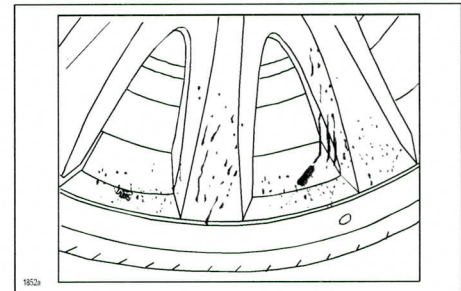
Some automotive cleaning products contain strong acid or alkali. When these types of cleaners are used to clean the wheels on Mazda vehicles, the chemicals contents penetrate the clear coating of the wheel surface and damage the paint under the clear coating. The damaged area has the appearance of dark stains.

- Mazda recommends using a mild soap or neutral detergent as stated in the owner's manual under Appearance Care in the Maintenance and Care section.
- DO NOT use a cleaning products containing strong acid or alkali contents to clean the wheels.
- DO NOT apply any type of specialized wheel cleaner to the wheels when they are hot (such as after driving the vehicle or if the vehicle has sat in the sun). Ensure wheel temperatures are the same as ambient temperature before cleaning.
- Within 15 minutes after any cleaner is applied, rinse the wheel thoroughly to completely remove cleaner.
- **Stains on Mazda Wheels caused by improper cleaning are not covered under the Mazda Vehicle Warranty.**
