Service Bulletin

SHOCK ABSORBER REPLACEMENT GUIDELINES

APPLICABLE MODEL(S)/VINS

Bulletin No: 02-004/16	Last Issued: 02/15/2016
© 2016 Mazda Motor of America, Inc.

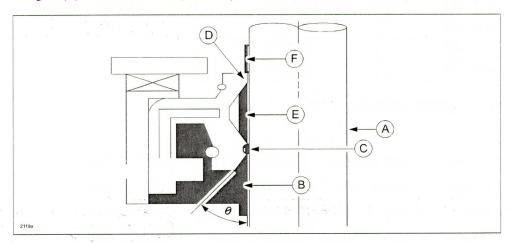
CAUSE OF OIL SEEPAGE

Oil seepage is caused by the following factors and is not a problem:

- A small amount of oil seeps outside through the dust lip during normal operation.
- The oil film thickness is uneven due to production variation of rod and seal.

When the rod (A) receives input from the road and extends upward, most of the oil (B) on the rod is scraped off by the main lip (C) and some remains inside the dust lip (D). When the rod extends further, then most of the remaining oil (E) on the rod is scraped off by the dust lip, and a small amount of oil seeps out (F).

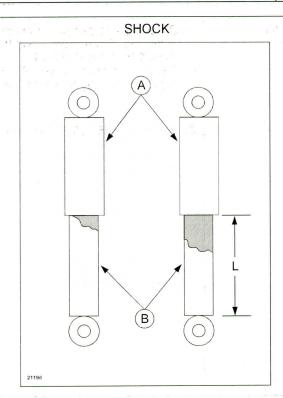
- Oil seepage comes out under the dust cover (A) and covers not more than 50% of the outer cylinder (B) length (L).
- The surface appears dirty due to oil and dust, but it is not wet with oil dripping / running down the sides.
- The damping function is still performing correctly.

Dealer action: Clean and dry the unit as much as possible. NO REPLACEMENT NECESSARY.

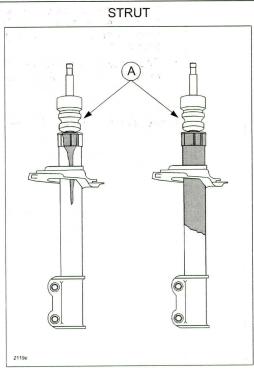
- Oil leakage comes out below the bump cap (A) and runs down the sides past the spring seat.
 - The surface appears wet with oil dripping / running down the sides.

Dealer action: REPLACE THE UNIT.

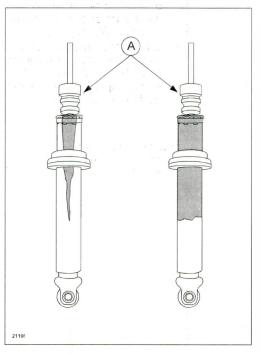
SHOCK ABSORBER WITH SPRING SEAT

- Oil leakage comes out below the bump cap (A) and runs down the sides past the spring seat.
- The surface appears wet with oil dripping / running down the sides.

Dealer action: REPLACE THE UNIT.

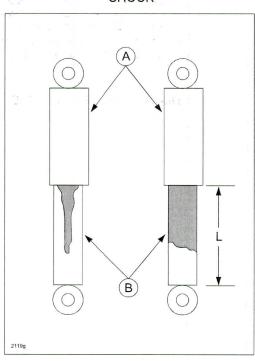
SHOCK

- Oil leakage comes out under the dust cover (A) and covers 50% or more of the outer cylinder (B) length (L).
- The surface appears wet with oil dripping / running down the sides.

Dealer action: REPLACE THE UNIT.
