Subject: CREAKING NOISE FROM FRONT LOWER CONTROL ARM BUSHINGS	Bulletin No: 02-006/16
	Last Issued: 02/23/2016

APPLICABLE MODEL(S)/VINS

2013-2016 CX-5

2014-2016 Mazda6

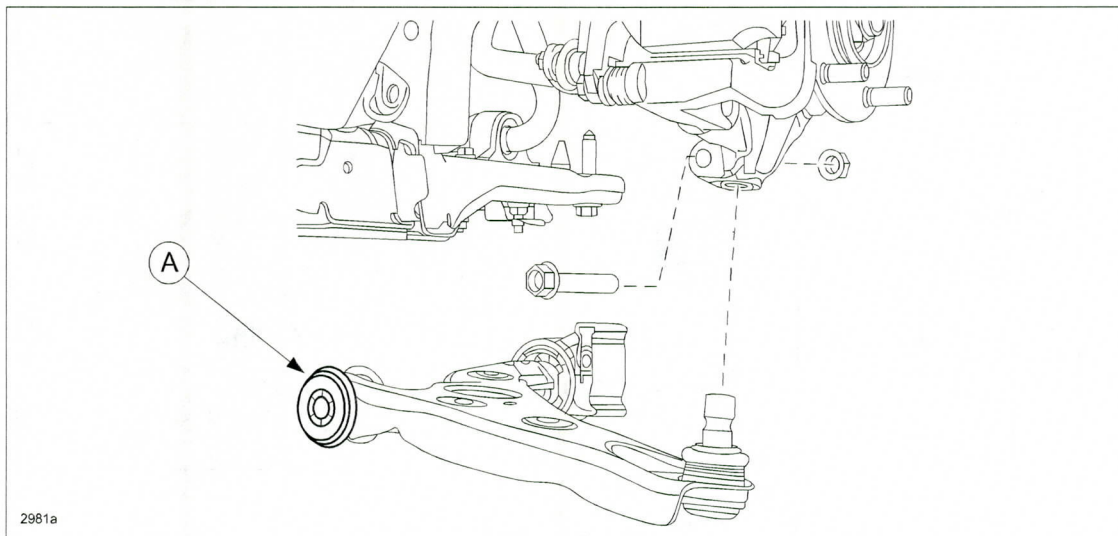
Some vehicles may exhibit a creaking noise from under the front of the vehicle when driving over bumps. The noise occurs at approx. 12 - 25 mph (20 - 40 Km/h) when the road surface is wet or after a car wash. The noise becomes more noticeable when driving over higher bumps.

The creaking noise is caused when the front lower control arm bushing(s) (A) become wet.

Customers having this concern should have their vehicle repaired using the following repair procedure.

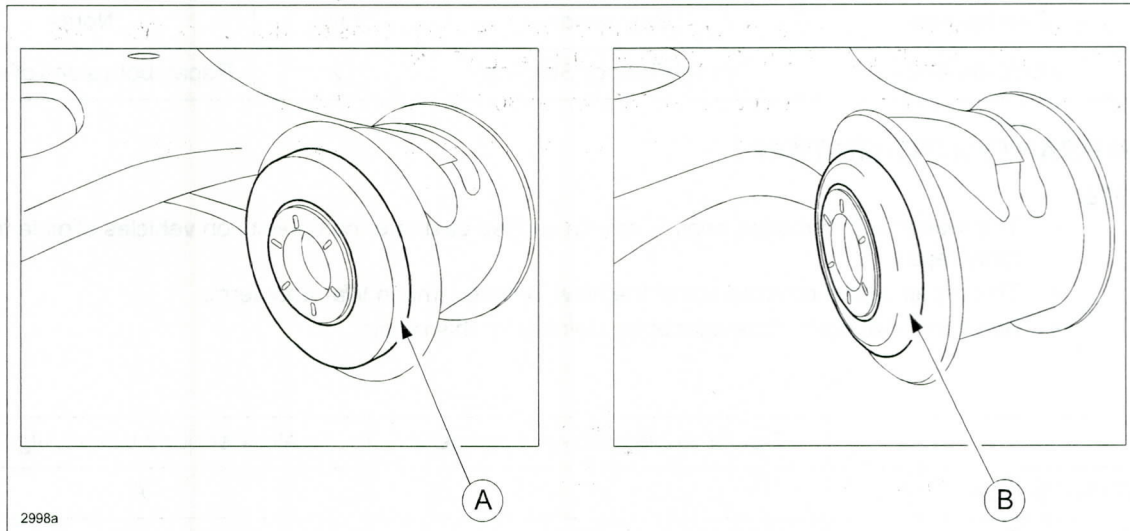
CAUTION: Make sure the bushing has been properly inserted by verifying that the bushing tab **IS FULLY EXPANDED**, as shown in the illustration to the left (A). The illustration to the right (B) shows an example of a bushing tab that **IS NOT FULLY EXPANDED**.
