Subject: RATTLE / CHATTER NOISE FROM REAR DIFFERENTIAL	Bulletin No: 03-001/16
	Last Issued: 01/08/2016

2013-2016 CX-5 AWD vehicles with VINs lower than JM3KE*****725078 (produced before October 1, 2015)

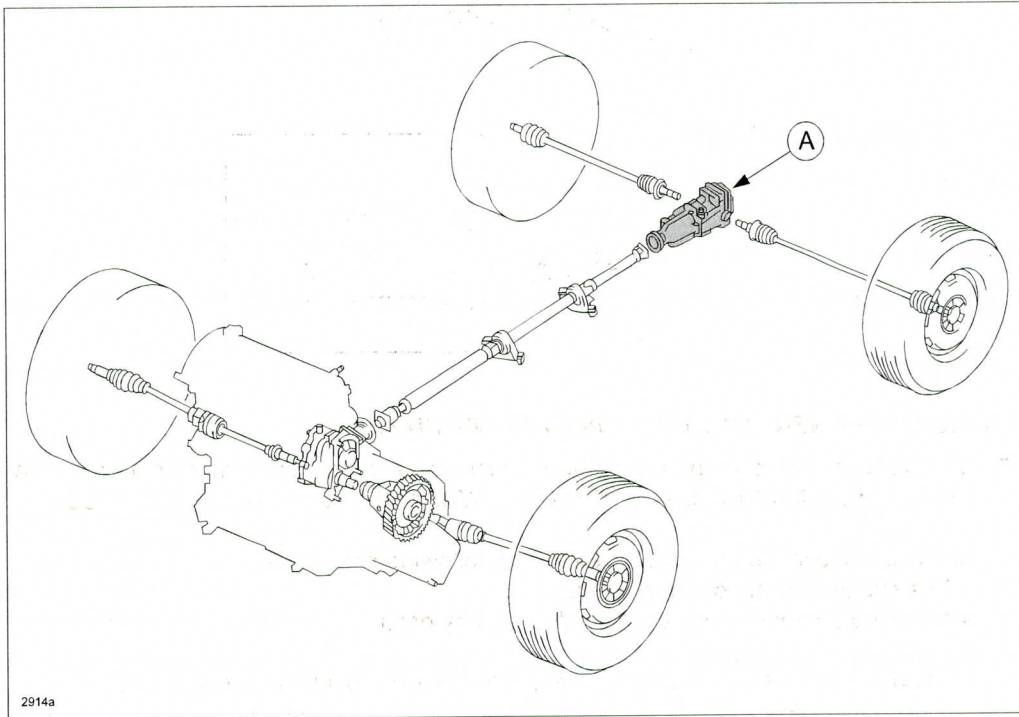
While driving at low speeds, some vehicles may exhibit a chattering / rattling type noise from the rear of the vehicle. The noise may be caused by a rear differential bearing failure.

1. Lift the vehicle **according to the instructions on MS3 online or the Workshop Manual** (section 00-00 JACKING POSITIONS, VEHICLE LIFT (2 SUPPORTS) AND SAFETY STAND (RIGID RACK) POSITIONS).
2. Verify the noise is heard from the rear differential component (A) when the wheel speed is approximately 3 to 6 mph (5 to 10 km/h).

3. Has the noise been verified?
 - a. Yes - Proceed to step 4.
 - b. No - This bulletin does not apply. Refer to MS3 online or Workshop Manual (section 03-03 NO.3 ABNORMAL NOISE AND/OR VIBRATION FROM COUPLING COMPONENT).
4. **Obtain Hotline Control Number (HCN) from MS3 online.**
5. Contact MASH at 888 832-8477, option 2, to obtain authorization to replace the rear differential component (including the coupling unit). Refer to MS3 online or Workshop Manual (section 03-14 REAR DIFFERENTIAL REMOVAL/INSTALLATION).

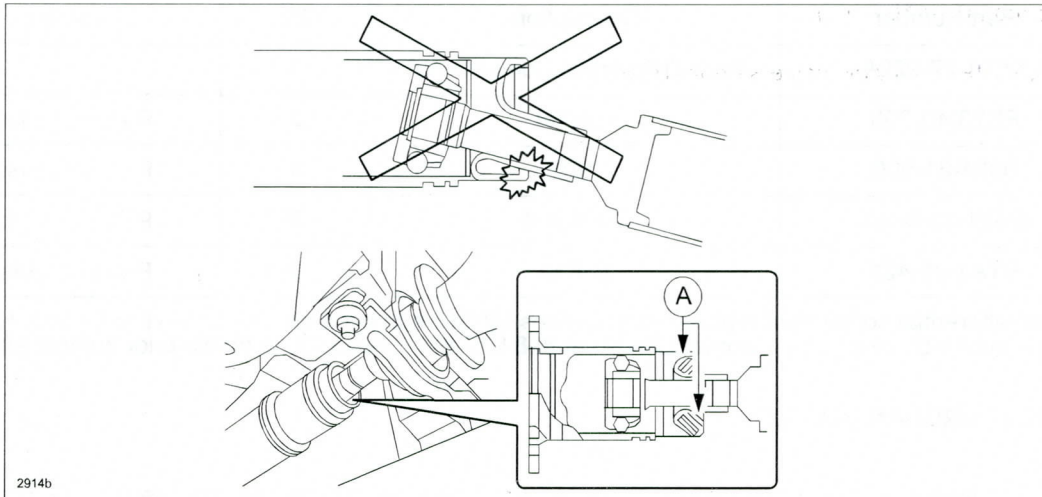
CAUTION: If the constant velocity joint angle is excessive during propeller shaft removal/installation, the constant velocity joint boot may be damaged when contacting the metallic cover. Protect the constant velocity joint boot by inserting a shop rag (A) between the boot and the metallic cover.

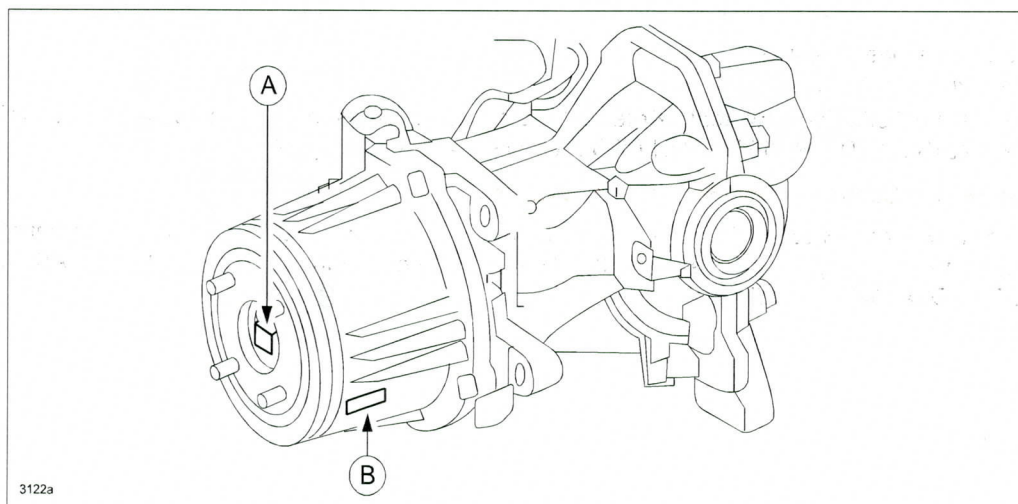
CAUTION: After part replacement, write characteristic value of new coupling component to 4WD control module (from M-MDS toolbox, "Chassis", "4WD/AWD", "Coupling Calibration Data Writing").

If this is not completed, it may result in the following conditions:

- The system will not operate normally.
- Coupling component durability problems may occur.

Obtain characteristic value from label (A) or mark (B) locations shown below.

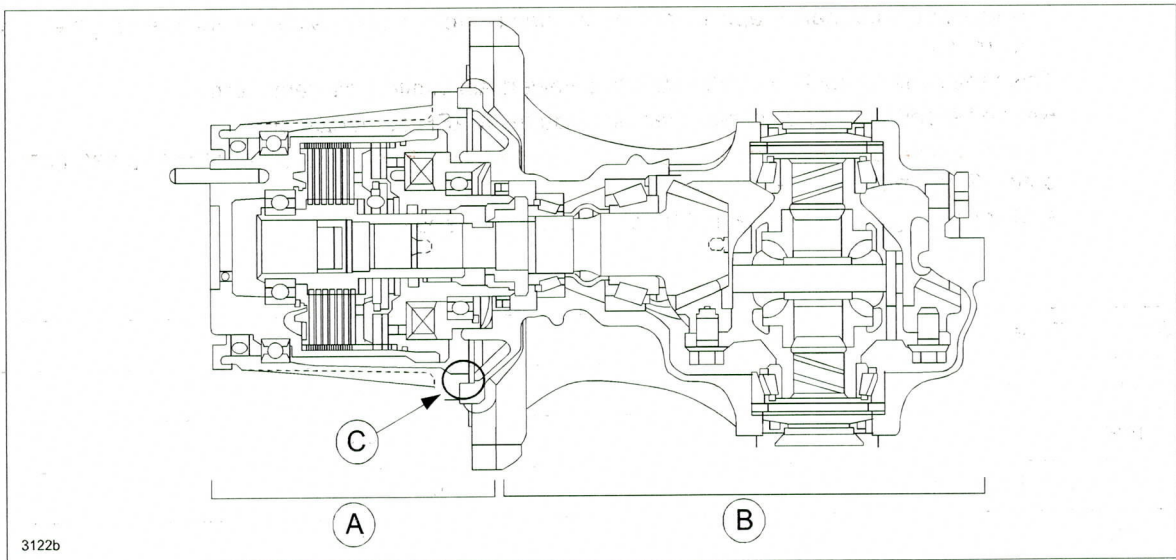
- New coupling unit (A) (KE01-27-97XA) and differential housing (B) are used during mass-production.
- New coupling unit IS NOT INTERCHANGEABLE WITH THE OLD DIFFERENTIAL HOUSING due to an increase in guide (C) length.

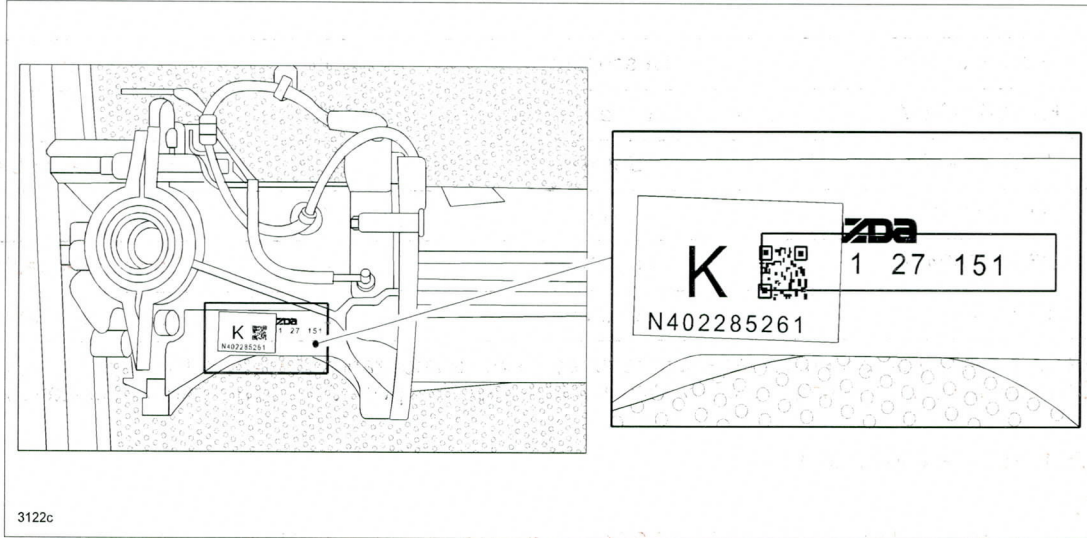
- The **OLD** differential housing has no suffix (KA01-27-151) in the molded part number (as shown below).
- The **NEW** differential housing has an "A" suffix (KA01-27-151A) in the molded part number.
