<b>Subject:</b>  SQUEAKING/GRINDING NOISE FROM REAR BRAKE	<b>Bulletin No:</b> 04-001/16
	<b>Last Issued:</b> 01/14/2016

2014-16 Mazda3 vehicles with VINs starting with JM1

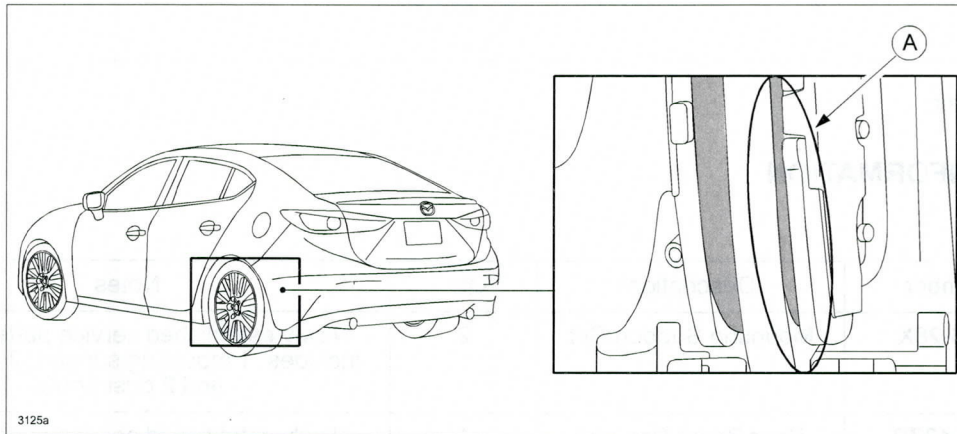
Some vehicles may experience a squeaking/grinding noise from the rear brake even after the brake pedal is released. Upon inspection, the caliper mounting support is corroded and one of the disc pad is abnormally worn out (A). This is caused by vehicle usage in an area using road salt. The surface of the mounting support may swell from corrosion causing premature disc pad wear and brake noise.

To correct the problem, an improved caliper mounting support has been newly established as a service part. The anti-corrosion surface treatment has been changed from Zn to Zn-Ni plating.

1. Verify that the caliper mounting support(s) is corroded and the disc pad(s) is abnormally worn out.
2. Replace the caliper mounting supports (both sides) with the modified service parts sets and attachments with new parts according to the instructions on MS3 online or the Workshop Manual (section 04-11 REAR BRAKE (DISC) REMOVAL/INSTALLATION).
