**Subject:****GRINDING NOISE FROM CLUTCH PEDAL WHEN DEPRESSING****Bulletin No:** 05-003/16**Last Issued:** 02/10/2016**APPLICABLE MODEL(S)/VINS**

2016 MX-5 vehicles with VINs lower than JM1ND\*\*\*\*\*104047 (produced before August 7, 2015)

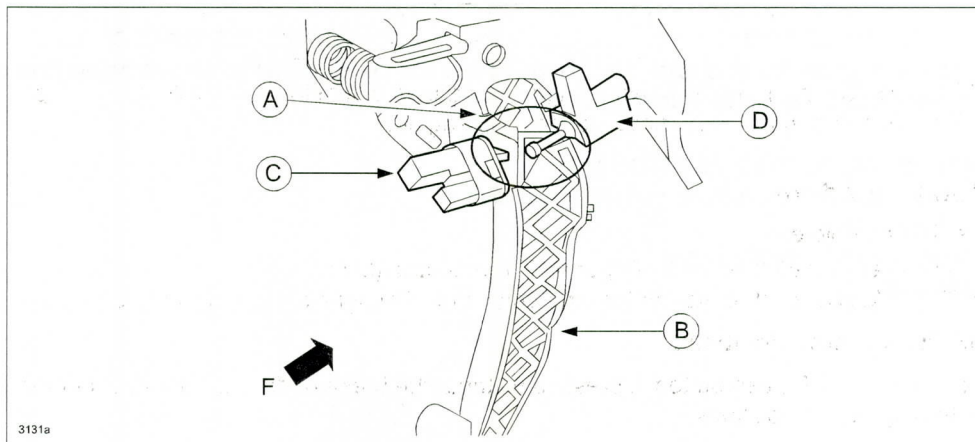
Some vehicles may exhibit a grind noise from around the clutch pedal when depressing it all the way down. This is caused by a stick-slip noise occurring at the contact point (A) between the clutch pedal (B) and the clutch pedal position switch (C) plunger and/or the clutch pedal and the starter interlock switch (D) plunger (F: Vehicle front).

To prevent the stick-slip noise from occurring, two pieces of silicon pad have been attached to the clutch pedal where the two switches contact.
