Subject: PASSENGER SIDE FOOTWELL AREA TOO HOT FROM HEAT RADIATED BY HEATER CORE	Bulletin No: 07-001/16
	Last Issued: 02/23/2016

2016 MX-5 vehicles with VINs lower than JM1ND*****108888 (produced before December 16, 2015)

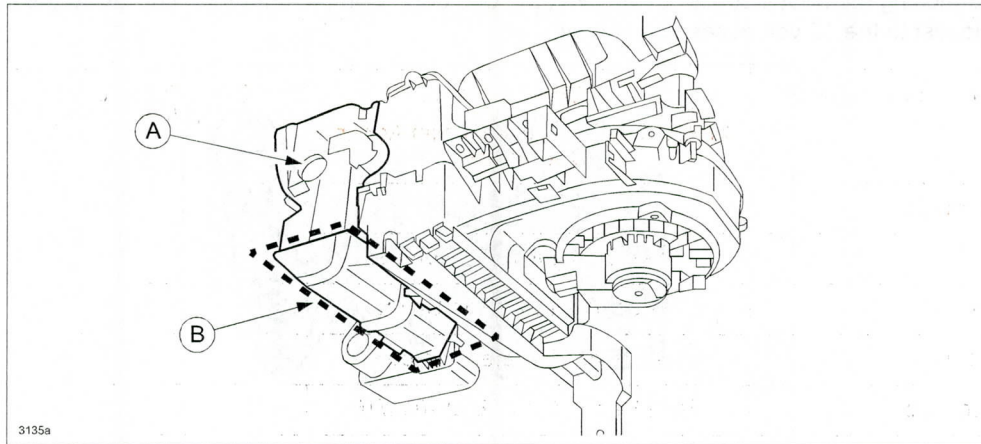
Some customers may complain that the temperature is too hot around the passenger side footwell area. This concern is due to heat radiated directly from the heater core (A) to this area. To correct this problem, a heat insulator (urethane sheet) is now attached to the under part of the heater core (B) to decrease the surface temperature.

Customers having this concern should have their vehicle repaired using the following repair procedure.
