Subject: COWL GRILLE POOR APPEARANCE	Bulletin No: 09-002/16
	Last Issued: 01/06/2016

2016 CX-3 vehicles with VINs lower than JM1 DK ***** 120952 (produced before November 18, 2015)

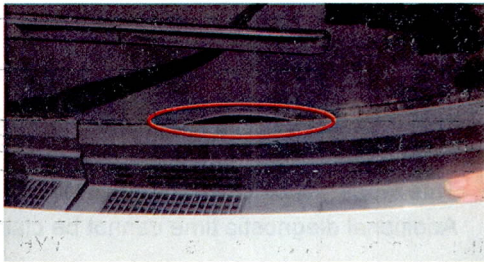
1. The bottom of the window shield is visible when the cowl grille is pushed.

OK	Poor Appearance

1. Verify customer concern.
2. Replace both side cowl grilles. Refer to MS3 online or Workshop Manual (section 09-16 COWL GRILLE REMOVAL/INSTALLATION).
3. Verify repair.

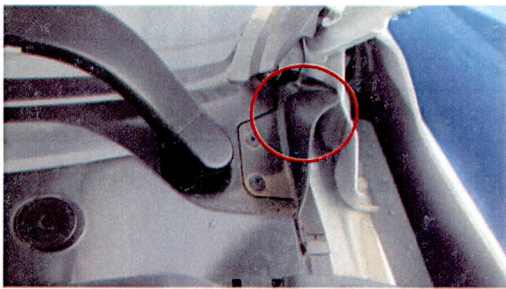
2. The side cover of the cowl grille is deformed.

OK	Poor Appearance
