© 2016 Mazda Motor of America, Inc.

Subject: FRONT POWER SEATS DO NOT SLIDE BACK AND FORTH	Bulletin No: 09-006/16
	Last Issued: 02/03/2016

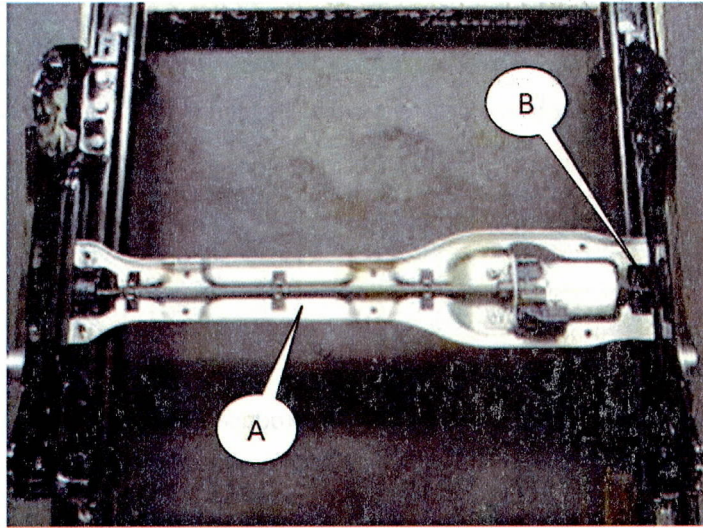
Power Slide Unit

Some customers may complain that the front power (driver and/or passenger) seats do not slide back and forth properly or that they may be completely inoperative. This concern may be caused by a foreign object getting stuck under the power slide unit (below) while in operation. This can cause motor mounting bracket (A) deformation, resulting in motor cable (B) breakage.

To eliminate this concern, the shape of the motor mounting bracket (A) has been modified to increase its strength.

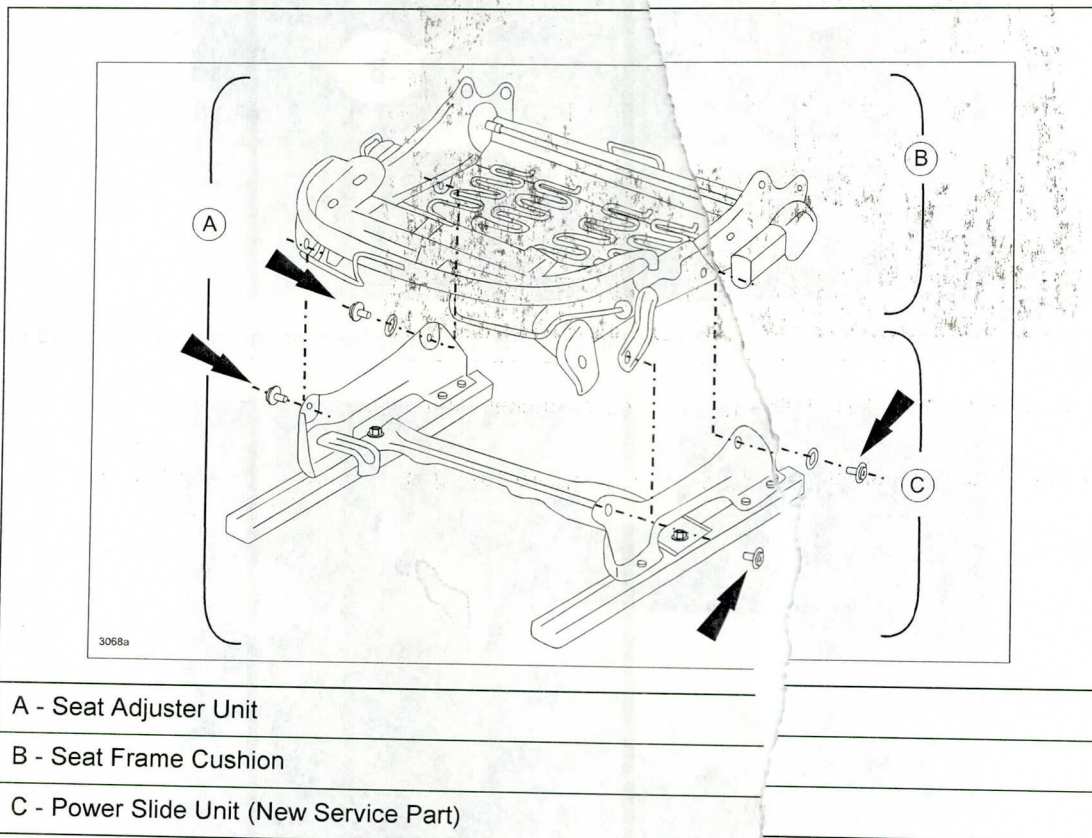
1. Verify the customer concern.
2. Inspect the motor cable (short one) and the motor mounting bracket:
 - Is the motor cable broken?
 - Is the motor mounting bracket deformed?
3. If the results are "Yes" for either of the above inspections, replace the power side unit with a newly established modified service part according to the replacement procedure.

4. Remove the seat adjuster unit (A) according to MS3 Online or the workshop manual (section 09-13 FRONT SEAT ADJUSTER UNIT REMOVAL/INSTALLATION).
