<b>Subject:</b> VARIOUS ELECTRICAL SYSTEM MALFUNCTION(S) RELATED TO C-15 CONNECTOR CORROSION	<b>Bulletin No:</b> 09-008/16
	<b>Last Issued:</b> 02/17/2016

2013-2015 CX-5 vehicles with VINs lower than **JM3KE\*\*\*\*\*554564** (produced before Nov. 24, 2014)

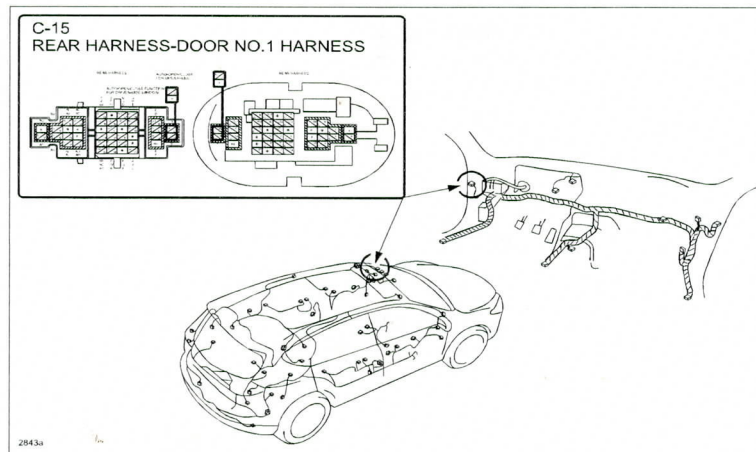
The symptoms listed above may be caused by corrosion of the C-15 connector terminals due to water intrusion through the front door. In low ambient temperatures, the door harness hardens. If the door is fully opened, it may create a gap between the door and the door harness grommet, which may allow water to enter through the gap.

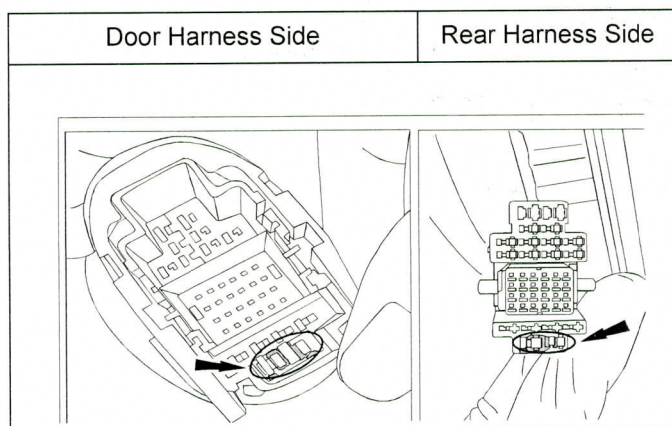
If one or more of the above mentioned symptoms can be confirmed, disconnect the C-15 connector (which joins the door harness and the rear harness). Inspect for any signs of corrosion of the C-15 connector terminals referring to the inspection procedure below.

- If there is any corrosion found on the terminals, go to next step.
- If there is no corrosion found on the terminals, this bulletin is not applicable. Troubleshoot the concern(s) according to the MS3 online instructions or the Workshop Manual.

- If there is any corrosion at the C-15 connector, replace the door harness and repair the rear harness according to the following repair procedure.
  - If there is no corrosion found at the C-15 connector, this bulletin is not applicable. Troubleshoot the concern(s) according to the MS3 online instructions or the Workshop Manual.
1. Verify the customer concern.
  2. Record customers pre-set radio stations.
  3. Slide the driver side front seat fully backwards.
  4. Disconnect the negative battery cable.
  5. Disconnect the C-15 connector according to the MS3 online instructions or the Workshop Manual (section 09-11 FRONT DOOR REMOVAL/INSTALLATION).
  6. Inspect for any corrosion found on the terminals shown below.
